Council Assessment Panel Agenda & Reports

plot date:	20/12/2023	status:	PRELIMINARY
scale:	As indicated	client name:	Kathrin, Jessica & Matthew
DD no:	221023	project no:	
drawn by:	JL	PROPOSED RESIDENCE	
checked by:	JA	project address:	10 GRAY ST, NORWOOD
		stage no.:	P100
		drawing title:	GENERAL LOCATION

**ARBORICULTURAL REPORT
DEVELOPMENT IMPACT ASSESSMENT**

14 August + RFI 8 November 2023
Anthony Cirocco Design
10 Gray Street Norwood
tas - 3088

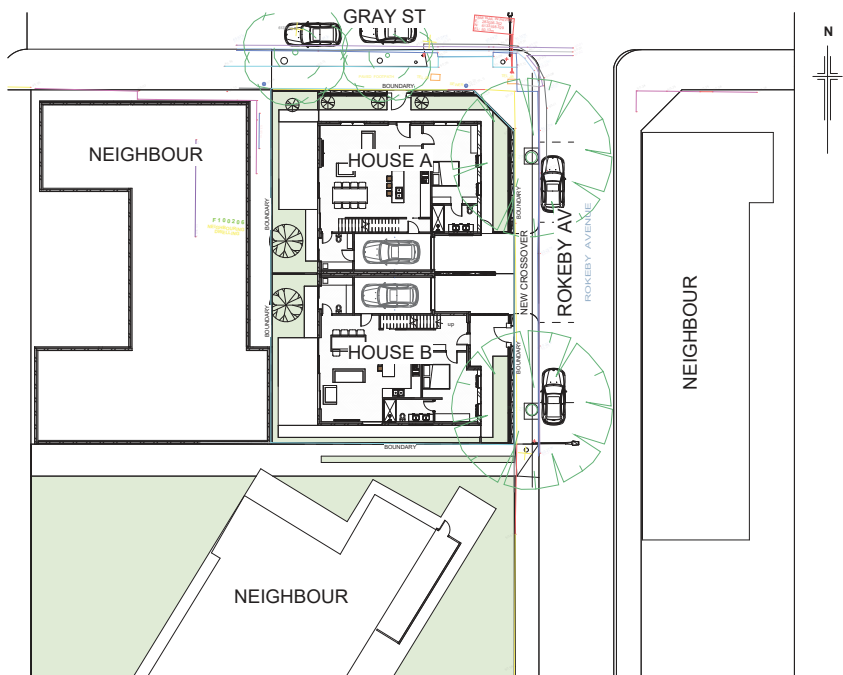
1 LOCATION PLAN
1 : 200

AREAS	Sq.m		
TOTAL LAND	232	SITE COVERAGE	126/232 = 54.3%
GF LIVING	126.0	PRIVATE OPEN SPACE	= 85.0 Sq.m
FIRST FL LIVING	56.0		
OUTDOOR LIVING	19.0	LANDSCAPE SPACE	= 35.7 Sq.m
TOTAL	= 201.0

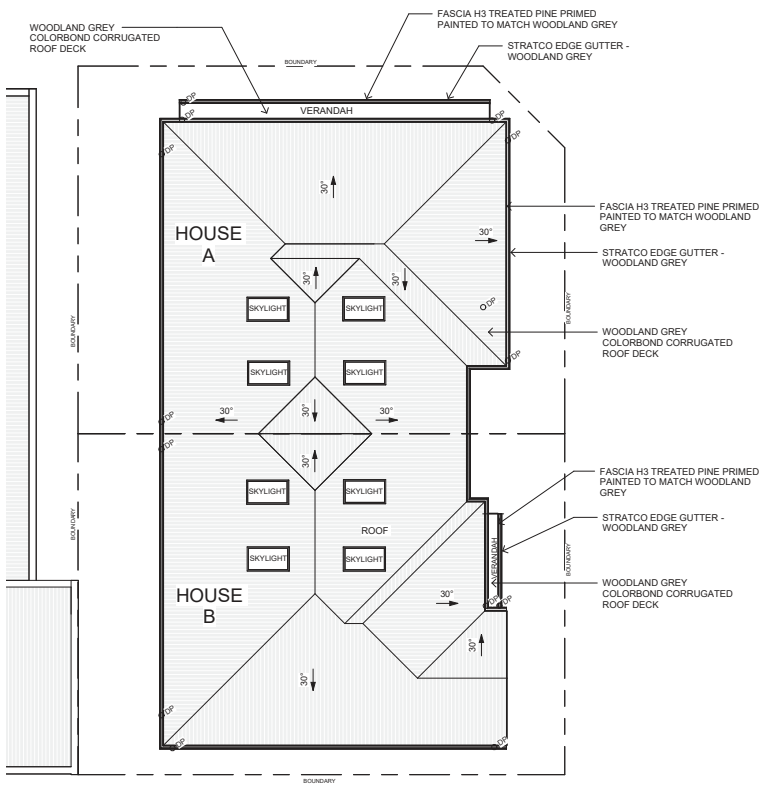
○ DOWN PIPE
 ○ CONNECT DOWNPIPE TO STORMWATER SYSTEM

It should be noted that the plans indicate a hard-surfaced area in the rear yard of each dwelling, presumably for a future covered outdoor entertaining area. However, no verandahs have been applied for with this application – the notation of a downpipe in the corner of these areas is considered to be a drafting error.

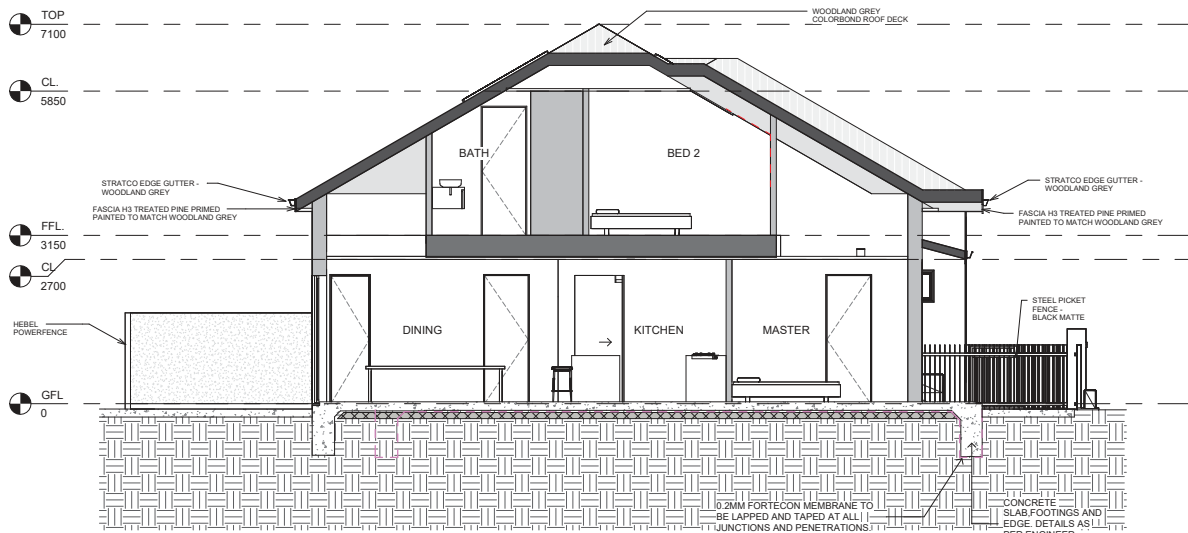
1 SECTION B
1 : 50

FINISHES:	
WALLS:	GROUND FLOOR: BRICK VENEER - WHITE TEXTURED COAT RENDER WHITE WASH 2 & WHITE WASH 4 BY HAYMES COLOUR TO FRONT FACADE AND BASKET RANGE SANDSTONE HONED FACE
WINDOWS:	MATT BLACK ALUMINIUM FRAMES
EXTERIOR DOOR :	MATT BLACK ALUMINIUM FRAMES WITH SOLID TIMBER DOOR / GARAGE DOOR - WOODLAND GREY
MAIN ROOF:	"WOODLAND GREY" COLORBOND ROOF DECK / "WOODLAND GREY" EDGE GUTTERS & FASCIA H3 TREATED PINE PRIMED PAINTED WOODLAND GREY
PAVING AND DRIVEWAY:	EXPOSED AGGREGATE CONCRETE, PAVERS
FENCE:	NEW BOUNDARY FENCE (HEBEL POWERFENCE PAINTED WHITE WASH 1 BY HAYMES), STEEL PICKET FENCE (FRONT FENCE), BLACK MATTE STEEL GATE

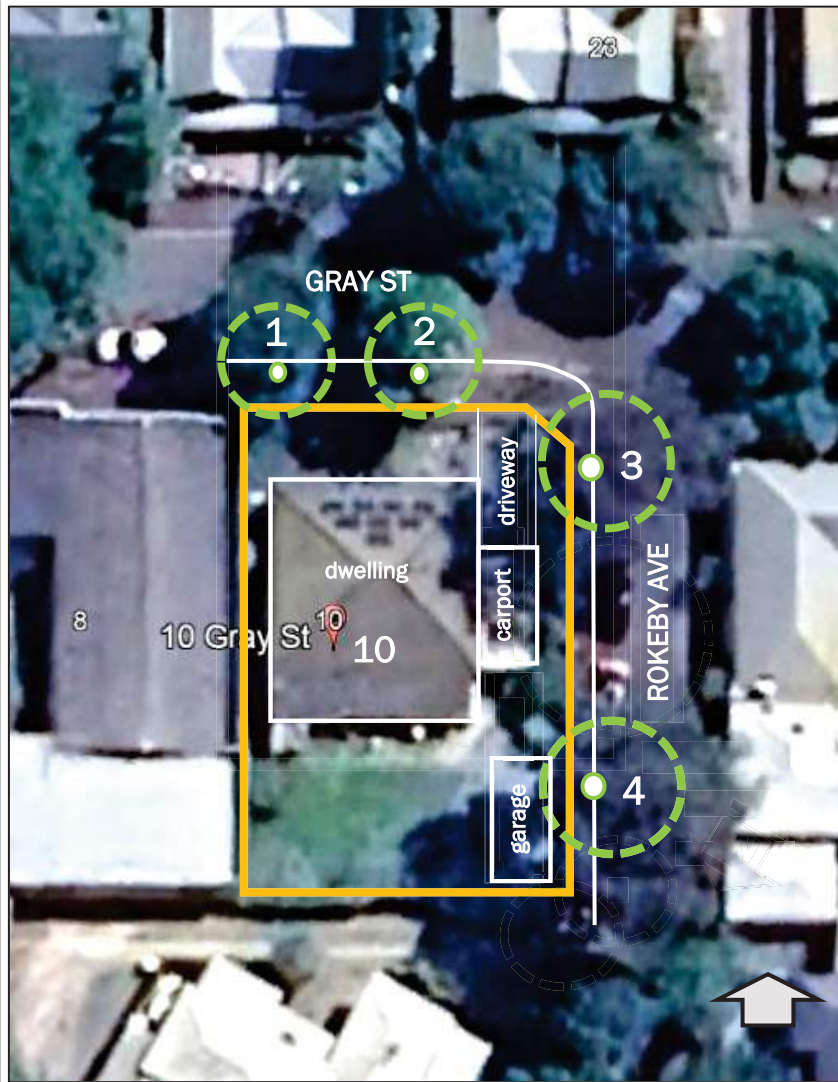
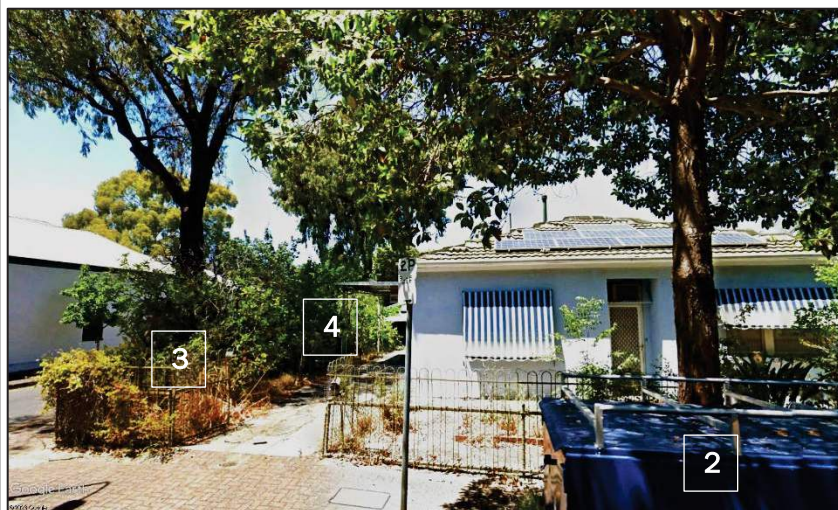
View to east. Dwelling orientates north with car port off side to east and driveway/site access near street corner. Tree 2 in Gray Street foreground and Trees 3 and 4 in Rokeby Ave.

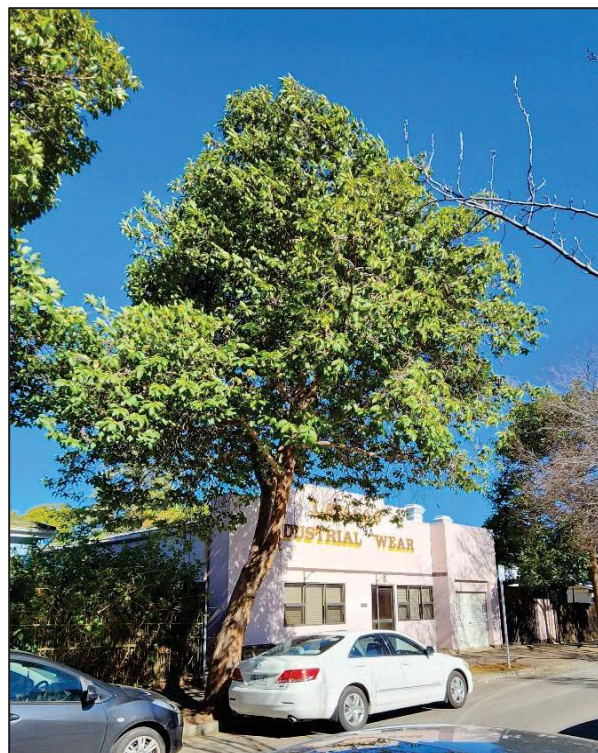
TREE 1	<i>Lophostemon confertus</i> Brushbox
LOCATION	Approx aligns with southern boundary projection into Gray St verge. Edge of trunk meets kerb.
TRUNK MEASURE	1280 @1.4, 1450 @1.0, 1720 @0.3 mtrs H
SIZE	Height 5 mtrs, Canopy 4 4 4 4 mtrs NSEW
PROTECTION	SRZ 2.5 TPZ 4.9 mtrs rad
LEGAL STATUS	Unregulated as per SA PDI Regs 2017 -3F 2(b)
AGE	230-25 yrs Early Mature
CONDITION	Health-Very Good, Structure-Good-Fair, Stability-Good Single upright trunk biased north 10° divides x 2 @ 2.5 mtrs high angled ribbed inclusion codominant half hemisphere canopies Stem 1 250 mm Ø 30° north, Stem 2 400 mm Ø 30° south. Hardy pollution and disruption tolerant species no longer favoured in urban areas due to nut drop nuisance. Approx 30-40 yrs remaining life expectancy.
QUALITY	Moderately High – Minor stem defect, no disease, no limb failures, well balanced, well maintained, high shade amenity

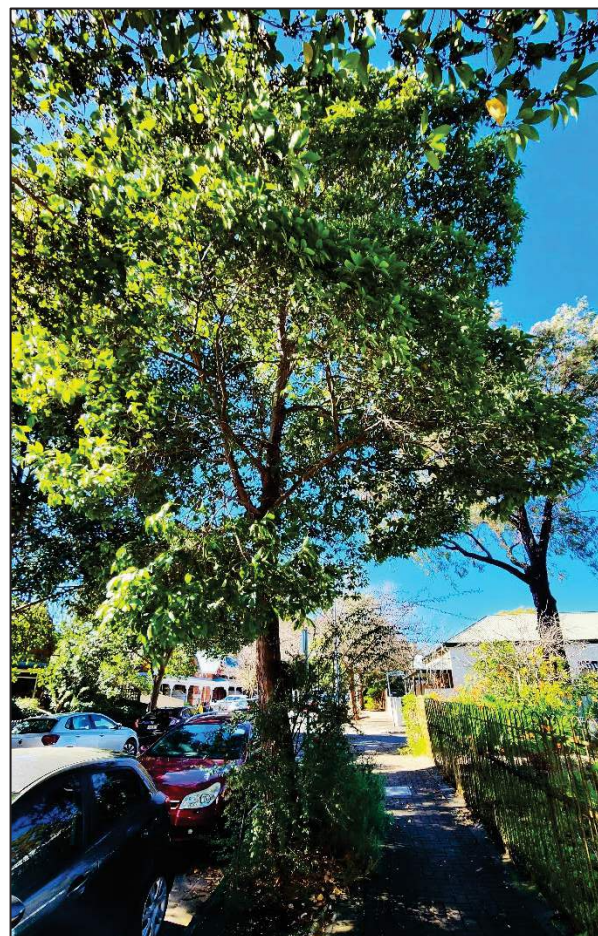
TREE 2	<i>Lophostemon confertus</i> Brushbox
LOCATION	Trunk on kerb edge 8.5 mtrs off southern boundary projection.
TRUNK MEASURE	1150 @1.4, 1250 @1.0, 1650 @0.3 mtrs H
SIZE	Height 5 mtrs, Canopy 4 4 4 4 mtrs NSEW
PROTECTION	SRZ 2.5 TPZ 4.7 mtrs rad
LEGAL STATUS	Unregulated as per SA PDI Regs 2017 -3F 2(b)
AGE	20-25 yrs Early Mature
CONDITION	Health- Good, Structure-Good-Fair, Stability-Good Upright single trunk, distinct taper, lateral 1 north @ 3 mtrs H apical codominant., Hardy pollution and disruption tolerant species no longer favoured in urban areas due to nut drop nuisance. Approx 30-40 yrs remaining life expectancy.
QUALITY	High - No defects, no disease, no limb failures, well balanced, well maintained, high shade amenity.

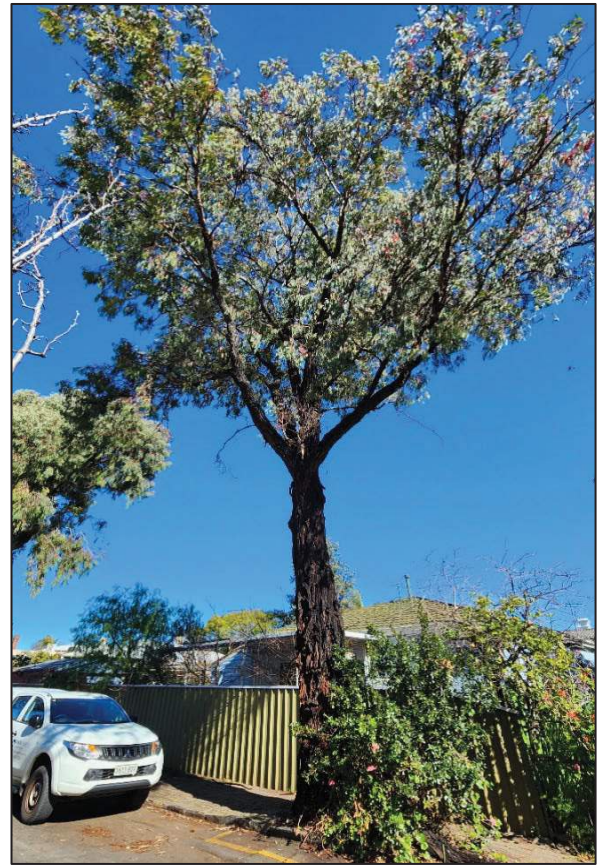
TREE 3	<i>Eucalyptus sideroxylon</i> Ironbark
LOCATION	4.5 mtr south of northern front boundary projection in Rokeby Ave footpath Edge of trunk meets kerb.
TRUNK MEASURE	2520 @1.4, 2640 @1.0, 2670 @0.3 mtrs H
SIZE	Height 15 mtrs, Canopy 10 8 6 6 mtrs NSEW
PROTECTION	SRZ 3.1 TPZ 10.1 mtrs rad
LEGAL STATUS	Regulated as per SA PDI Regs 2017 -3F 2(b)
AGE	40-45 yrs Over-Mature
CONDITION	Health-Fair, Structure-Good-Fair, Stability-Fair Single upright tapered trunk with lower limb removals to 3 mtrs H then high angled lateral limbs L1 400 mm Ø 60° north and north-west, L2 south 6 mtrs H 400 mm Ø 40° with main stem/limb cluster x 3 @ 8 mtrsH. Foliar density moderate, canopy coverage good. Disruption and compaction tolerant species with low limb flexibility resulting in limb fatigue in turbulent weather. Up to 10 yrs remaining useful lifespan.
FORM	Tall tapered stem forming upper peripheral apical canopy surrounding upper central canopy

QUALITY	Moderate-high proportion of small limbs and low foliar density indicates mildly stressed growing conditions possibly from heat bank. No obvious disease, well balanced, well maintained. Very large for confined street

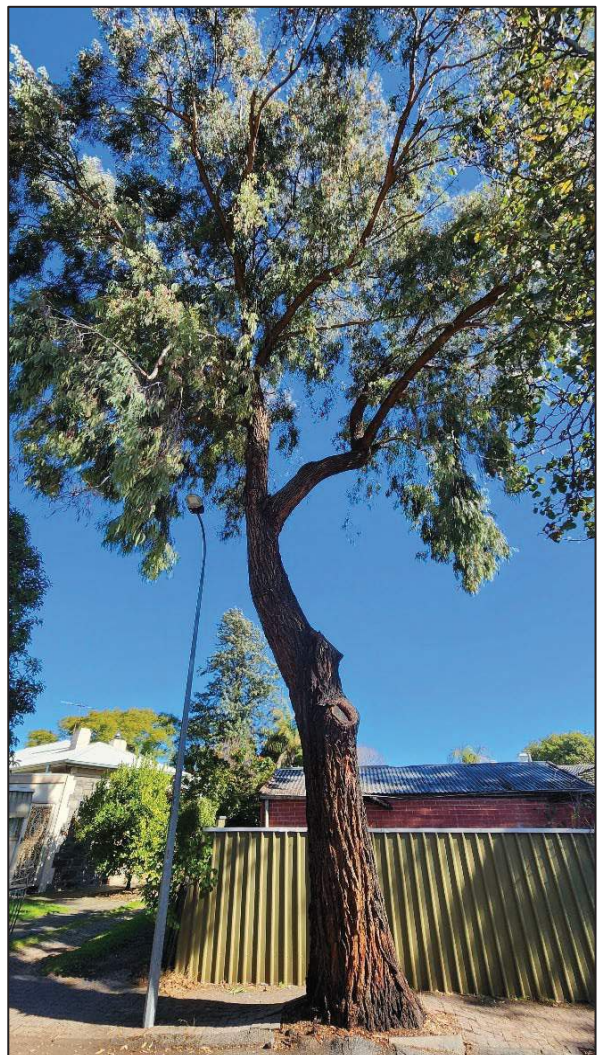
TREE 4	<i>Eucalyptus sideroxylon</i> Ironbark
LOCATION	2.2 mtrs north of southern rear boundary projection in Rokeby Ave footpath. Edge of trunk meets kerb.
TRUNK MEASURE	2580 @1.4, 2640 @1.0, 3040 @0.3 mtrs H
SIZE	Height 15 mtrs, Canopy 6 8 6 4 mtrs NSEW
PROTECTION	SRZ 3.1 TPZ 9.5 mtrs rad
LEGAL STATUS	Regulated as per SA PDI Regs 2017 -3F 2(b)
AGE	40-45 yrs Fully Mature
CONDITION	Health-Very Good, Structure-Good, Stability-Good Single upright tapered trunk with lower limb removals to 3 mtrs H diverts south corrects to vertical from L1 north 600 mm Ø 45° 6 mtrsH subdominant apical, limb cluster x 4 @ 9 mtrs with regrowth. Foliar density very good and canopy coverage very even. Disruption and compaction tolerant species with low limb flexibility resulting in limb fatigue in turbulent weather. Approx 20-25 yrs remaining life expectancy.
QUALITY	High - Size for age and condition indicates good response to larger growing area, no disease, no limb failures, well balanced, well maintained, high shade amenity

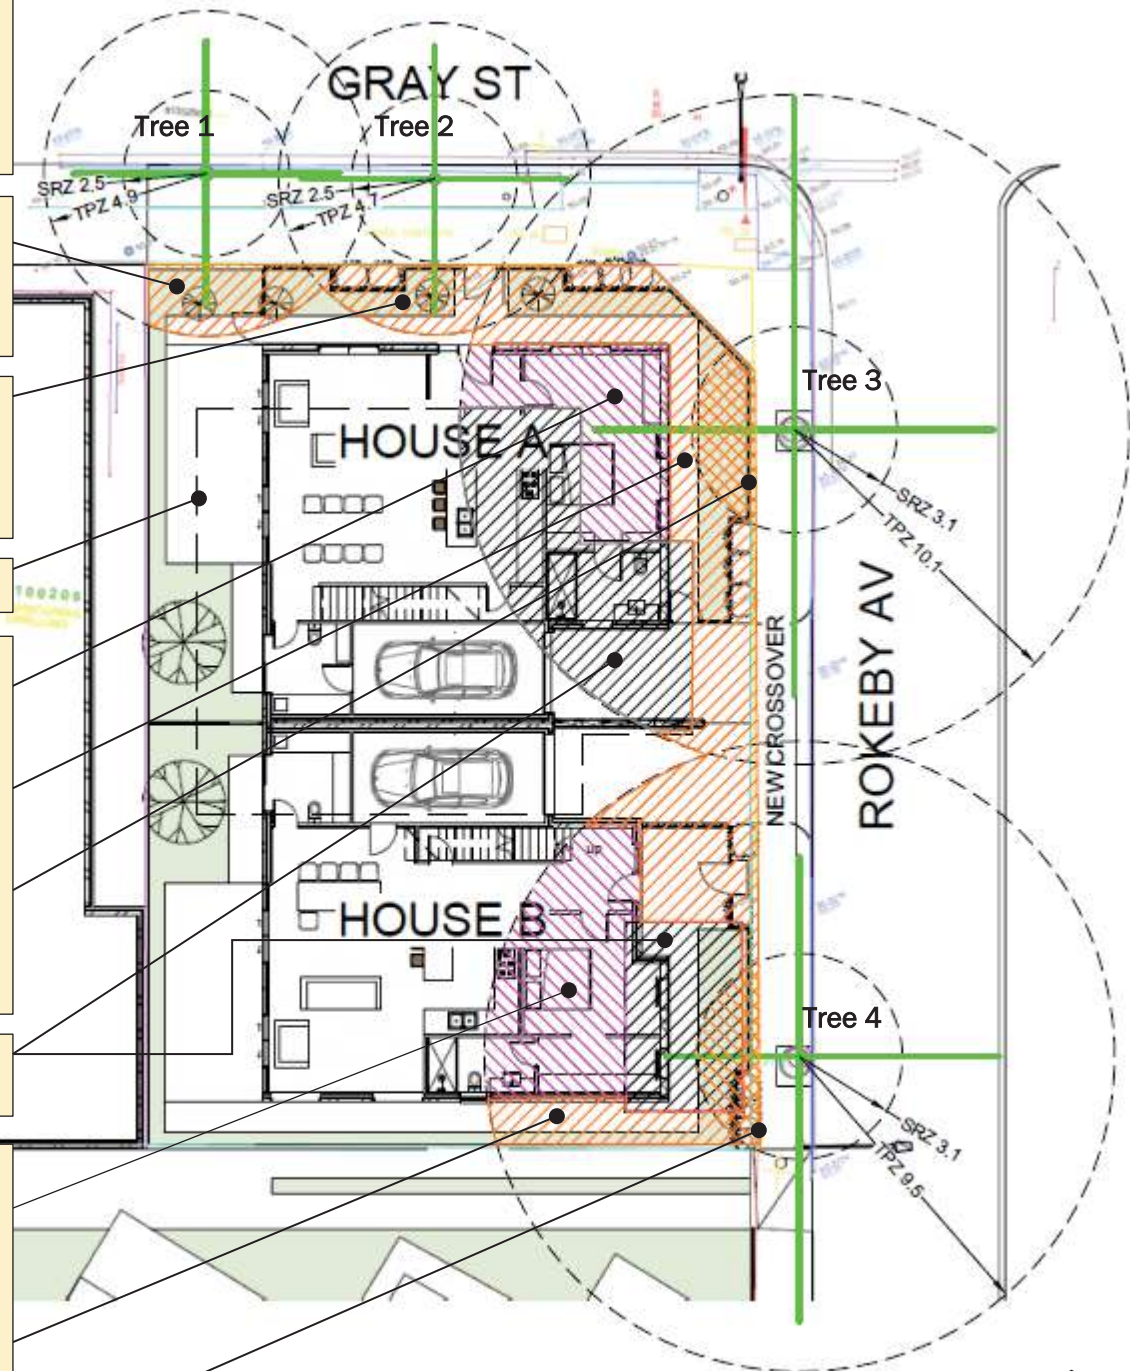
- 29 sqm or 10.2% of 283 sqm TPZ deep encroachment posed by proposed Dwelling B.
- 28 sqm shallow encroachment by new garden and peripheral pavement over previous rear garden beyond previous garage.
- Boundary fence piers acceptable in SRZ with hand dug root discovery

- Existing Sewer IP in Gray St verge may be retained for Dwelling A.
- Sewer, Water, Electricity, Gas (or not) multiple services routed to both dwellings via prop driveways off Rokeby between Trees 3 and 4 drilled from main to reduce trench impacts.

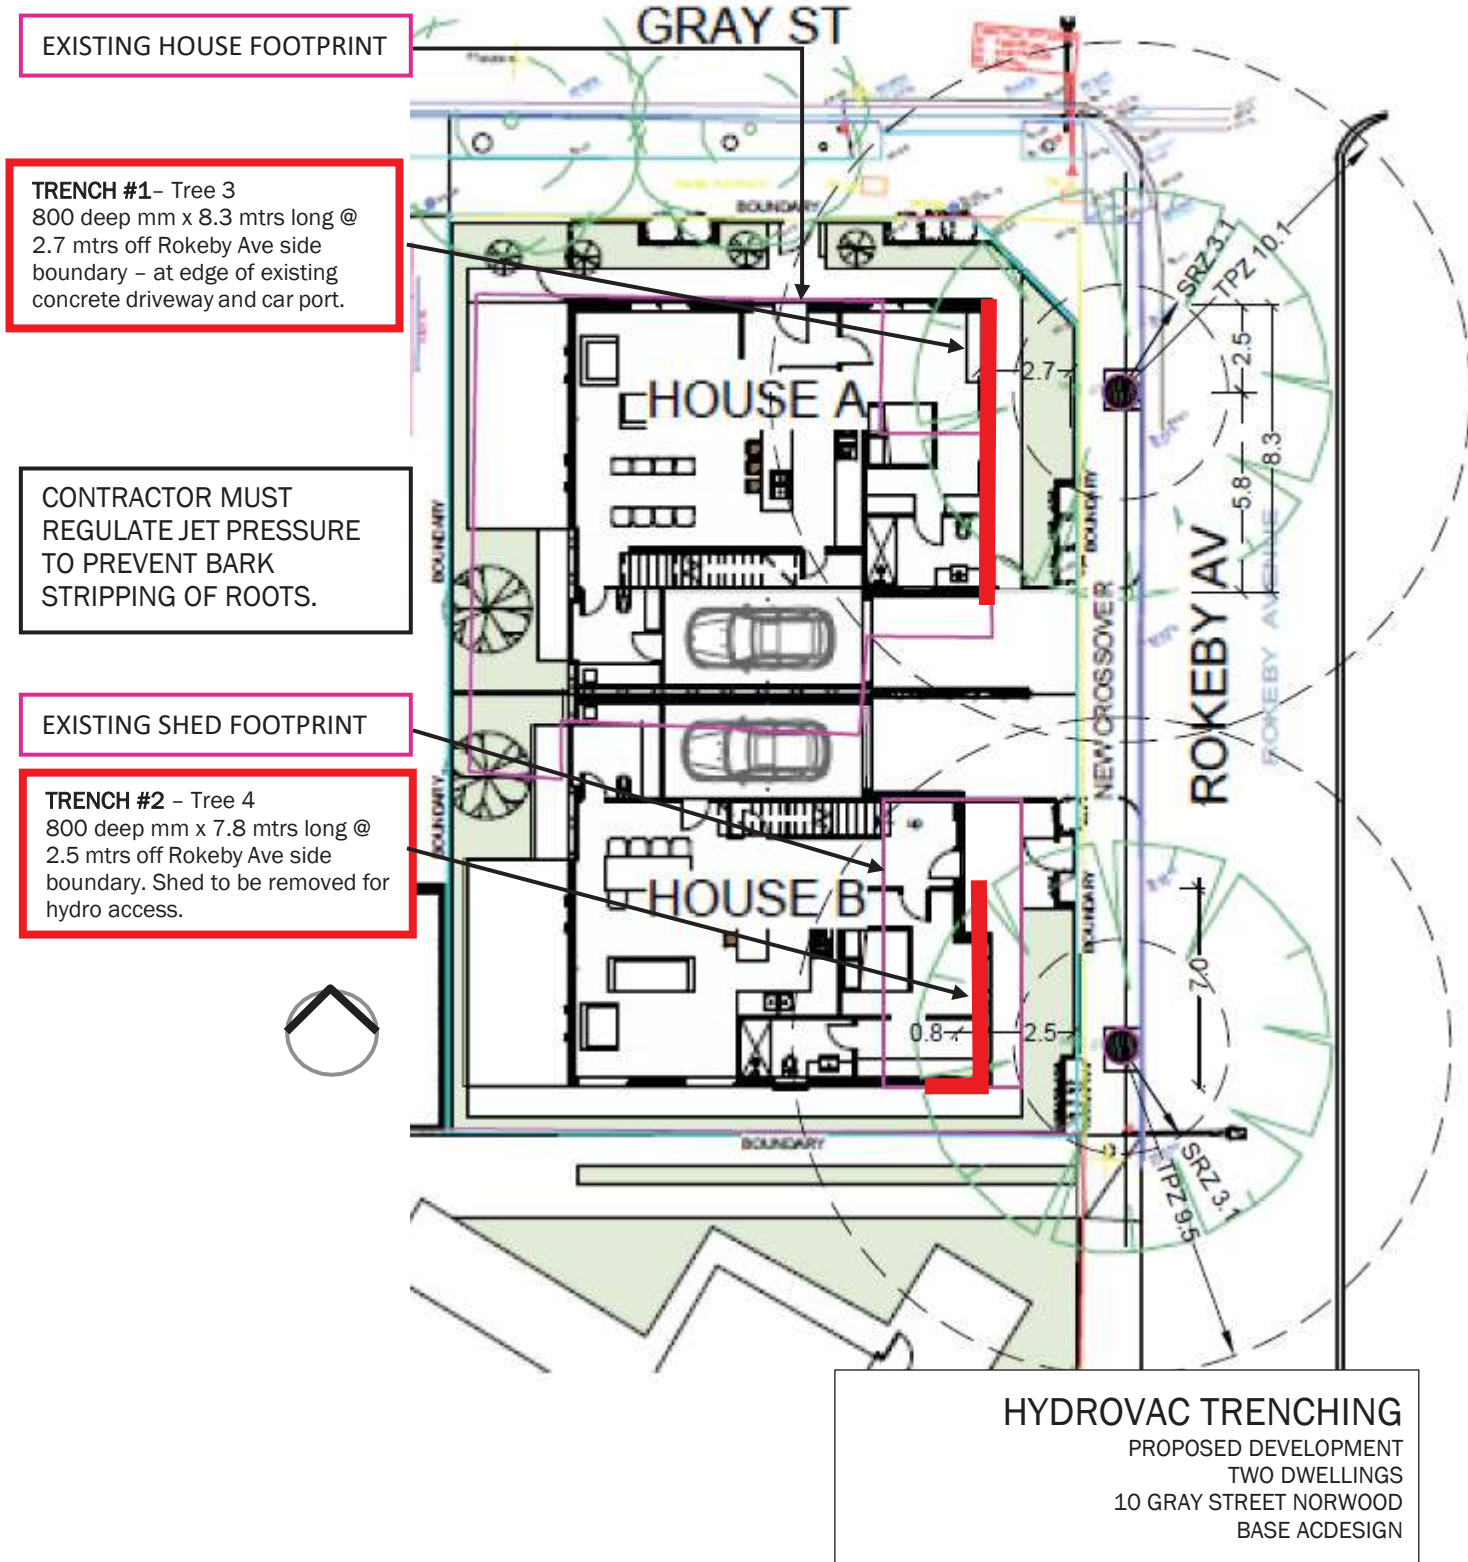
FINDINGS TRENCH #1

No.	CHAINAGE mtrs	SIZE mm Ø	DEPTH mm	ALIGNMENT
	0.0 North			
1	0.3	20	500	Perp
2	0.55	20	300	Perp
3	1.0	20	600	Perp
4	1.1	15	250	Perp
5	1.4	20	500	Perp
6	2.1	100	500	Perp
7	2.2	20	500	Perp
8	2.3	20	500	Perp
9	2.7	30	450	Perp
10	2.9	30	550	Perp
11	3.1	50	200	Perp
12	3.3	40	500	Perp
13	3.4 - 3.8	40	50	Long
14	4.1 - 4.7	40	50	Long
15	4.8 - 5.1	50	200	Long
	7.8 South

- 3 roots > 50 mm Ø.
 - Root 6, 11 and 12 largest discovered, low density, limited extent, near opposite, limited numbers, at anerobic depths considered unlikely structurally supportive.
 - Roots 13,14 and 15 possibly from the same root orientate from other nearby small tree, along previous edge of concrete driveway at shallow aerobic depth.
- Few roots extend westwards.
- Structural roots possibly deeper or focused elsewhere.

Findings of 4 Roots >40 mmØ in Trenches #1 and #2 surprising considering proximity of tree to trench, potentially higher quality root growing conditions in subject property's front and rear garden spaces, and alternative supposedly lower quality conditions under adjacent roadways.

Essentially, limited findings indicate that neither the health, structural condition or stability of Trees 3 or 4 would be affected by the minor encroachment posed by proposed development.

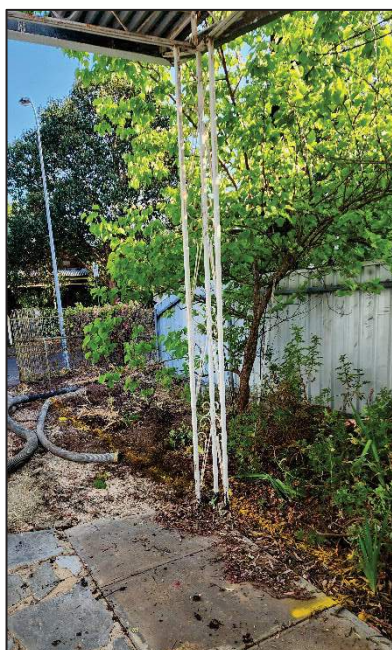
Discovery mark out 2.5 mtrs off eastern boundary. Small tree likely responsible for roots 13-15.

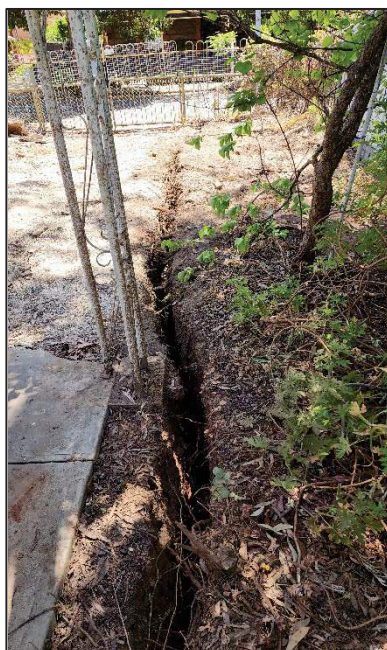
8.3 mtr long by 600 mm deep trench to driveway and car port edge.

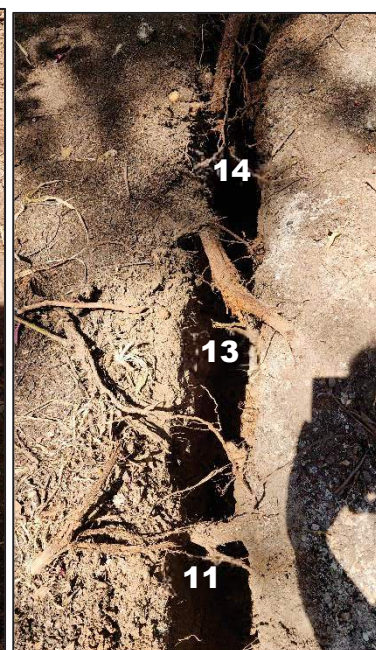
Small roots discovered extending into shade, not severed.

Larger diameter root (s) 13-15 shallow following edge of concrete pavement.

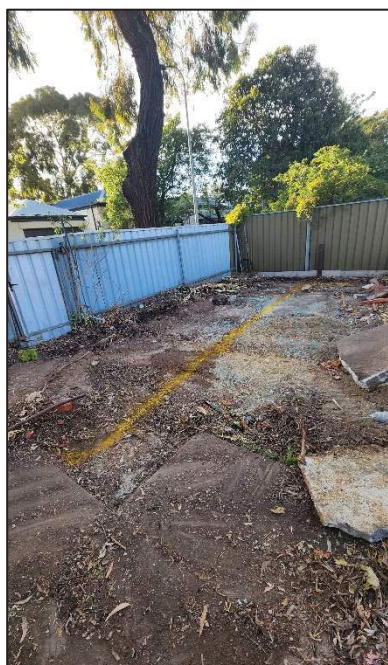
Discovery mark out 2.5 mtrs off eastern boundary after garage and slab demolished.

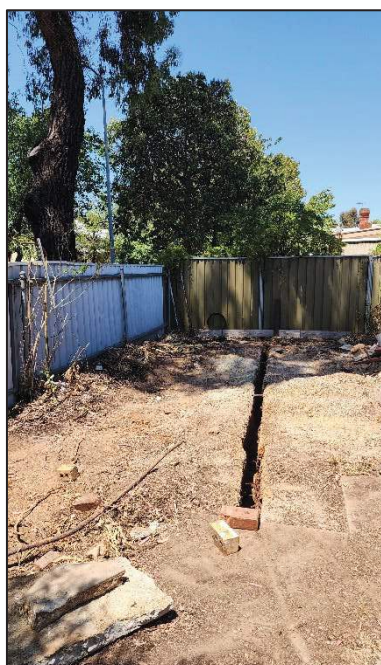
7.6 mtr long x 800 mm deep hydrovaccated trench completed.

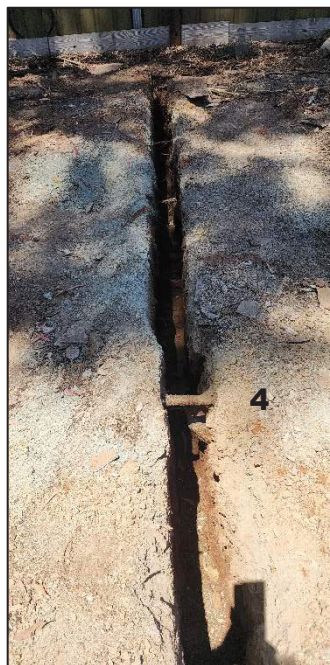
Very few roots encountered 1>50mmØ. New species *Water pipei* discovered.

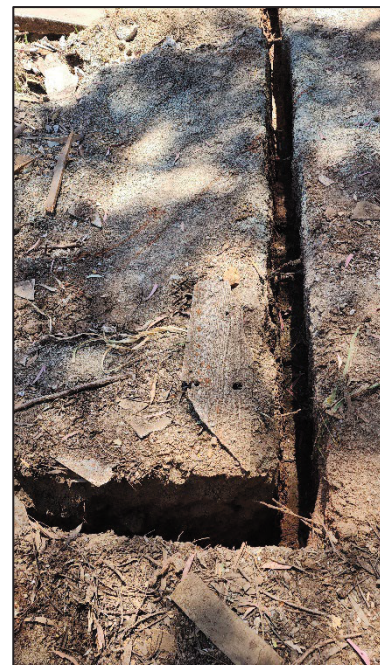
Trench extended to west given proximity to tree

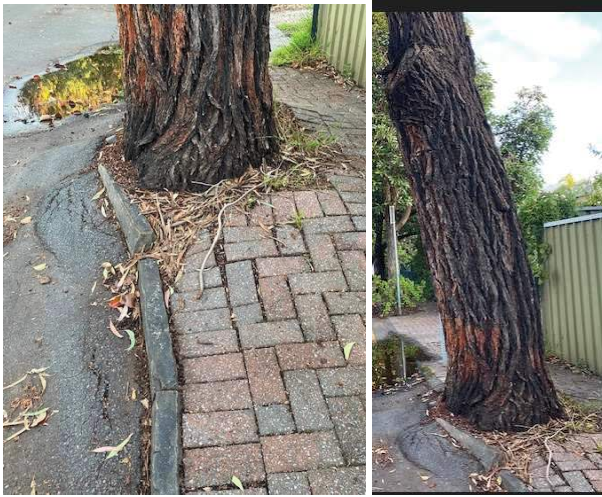
10. The tree outside House B (see below photos):
 - a. encroaches into Rokeby's width from the kerb edge by 780mm at floor level, and more at higher levels due to its lean; and

- b. encroaches along the length of Rokeby with the distance between the North end of this encroachment and the North of the parking restriction yellow line for number 5's driveway being 3200mm.

2. It is not safe to park a car alongside the tree outside of House B because of its encroachment into the road by at least 780mm and its lean into the road. Parking alongside means your car sits out at least 780mm from the line of other parked cars causing a hazard to other vehicles and passengers, and a possible insurance claim for you. It is actually not possible to park 780mm from the kerb because of the tree's lean meaning you actually have to park out further than that and have to take care not to get too close and bump the higher edge of your car causing damage.

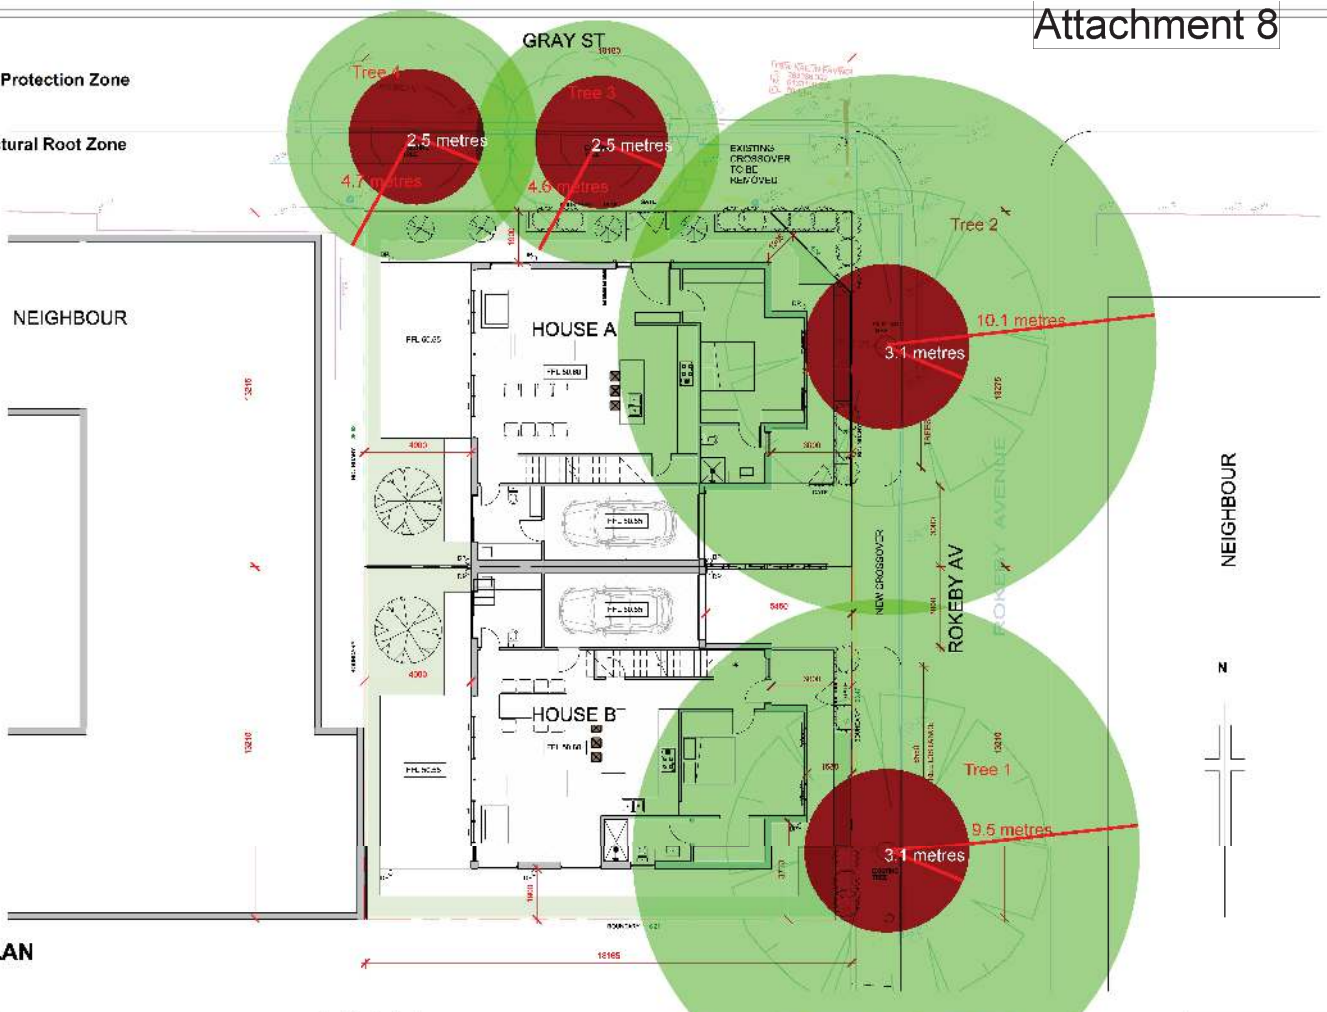
1 SITE PLAN
1:100

Structural Root Zone

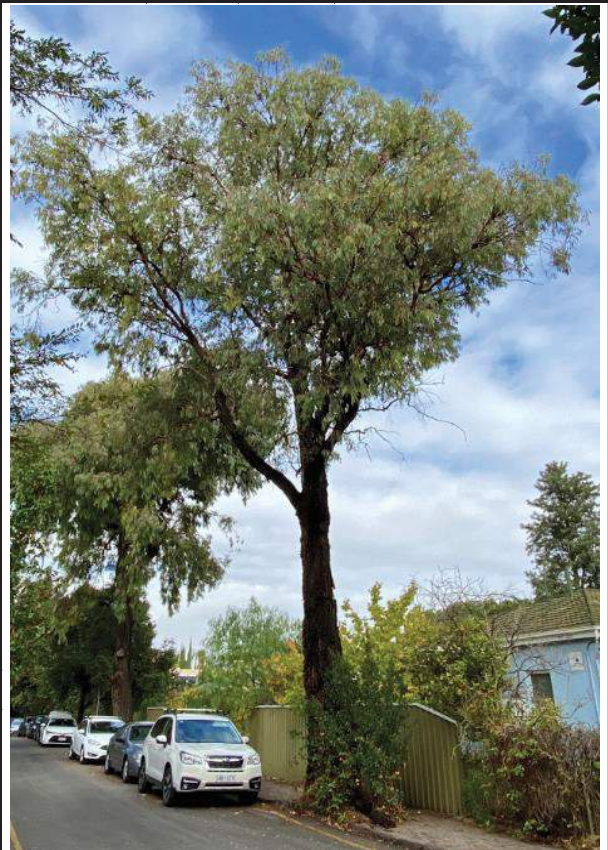
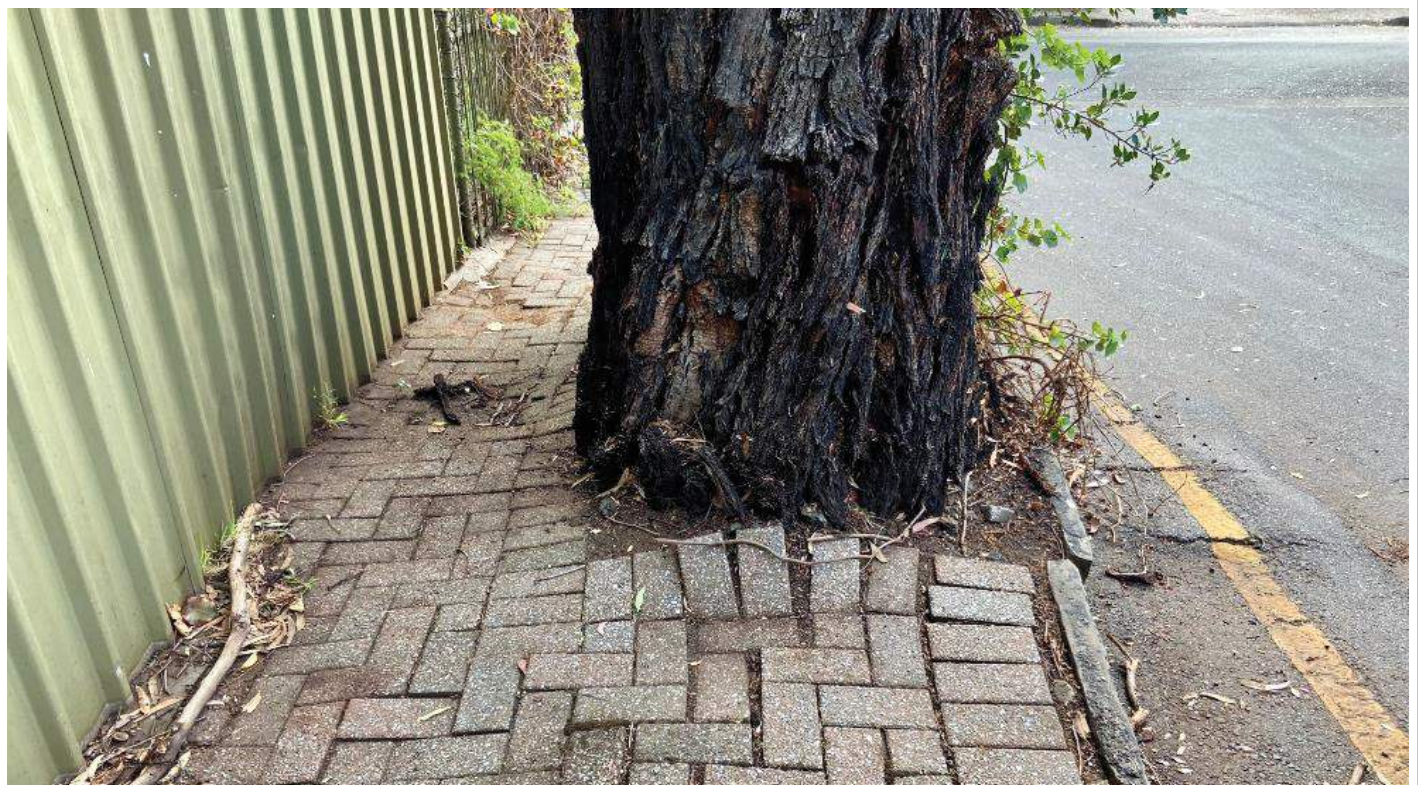
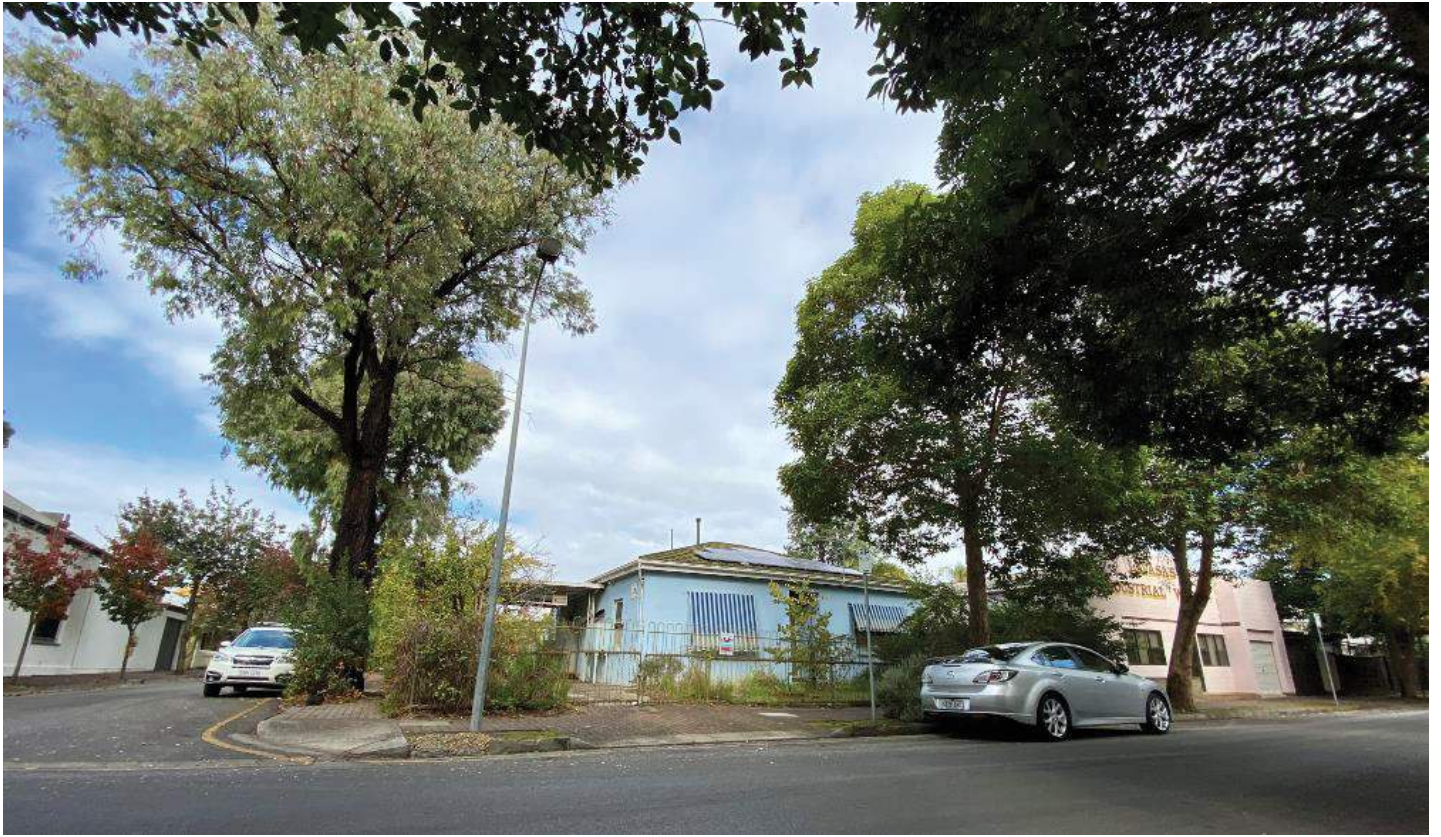
Image above shows 'tree 2' and Image below shows tree buttress and displacement of infrastructure. Image 3 shows current growing environment of the four trees that surround this potential development site, consisting of undisturbed garden bed, dwelling and minor infrastructure. The trees are likely to be a similar age to the dwelling.

The subject tree is a single stemmed specimen to 5m having had all its lower branches previously removed. Branch division occurs at 5m and again at 6m, these unions are well formed and support the trees branching framework which displays good attachments throughout the trees relatively sparse crown. Several small dead branches are evident throughout the trees crown indicating the tree having been through a period of gradual decline, at this stage overall health is fair and will be subject to changes to root growing environment. The tree is free of any structural defect that could be observed from ground level. The tree is currently <1m from the property boundary. **SRZ = 3.09m TPZ = 10.08m**

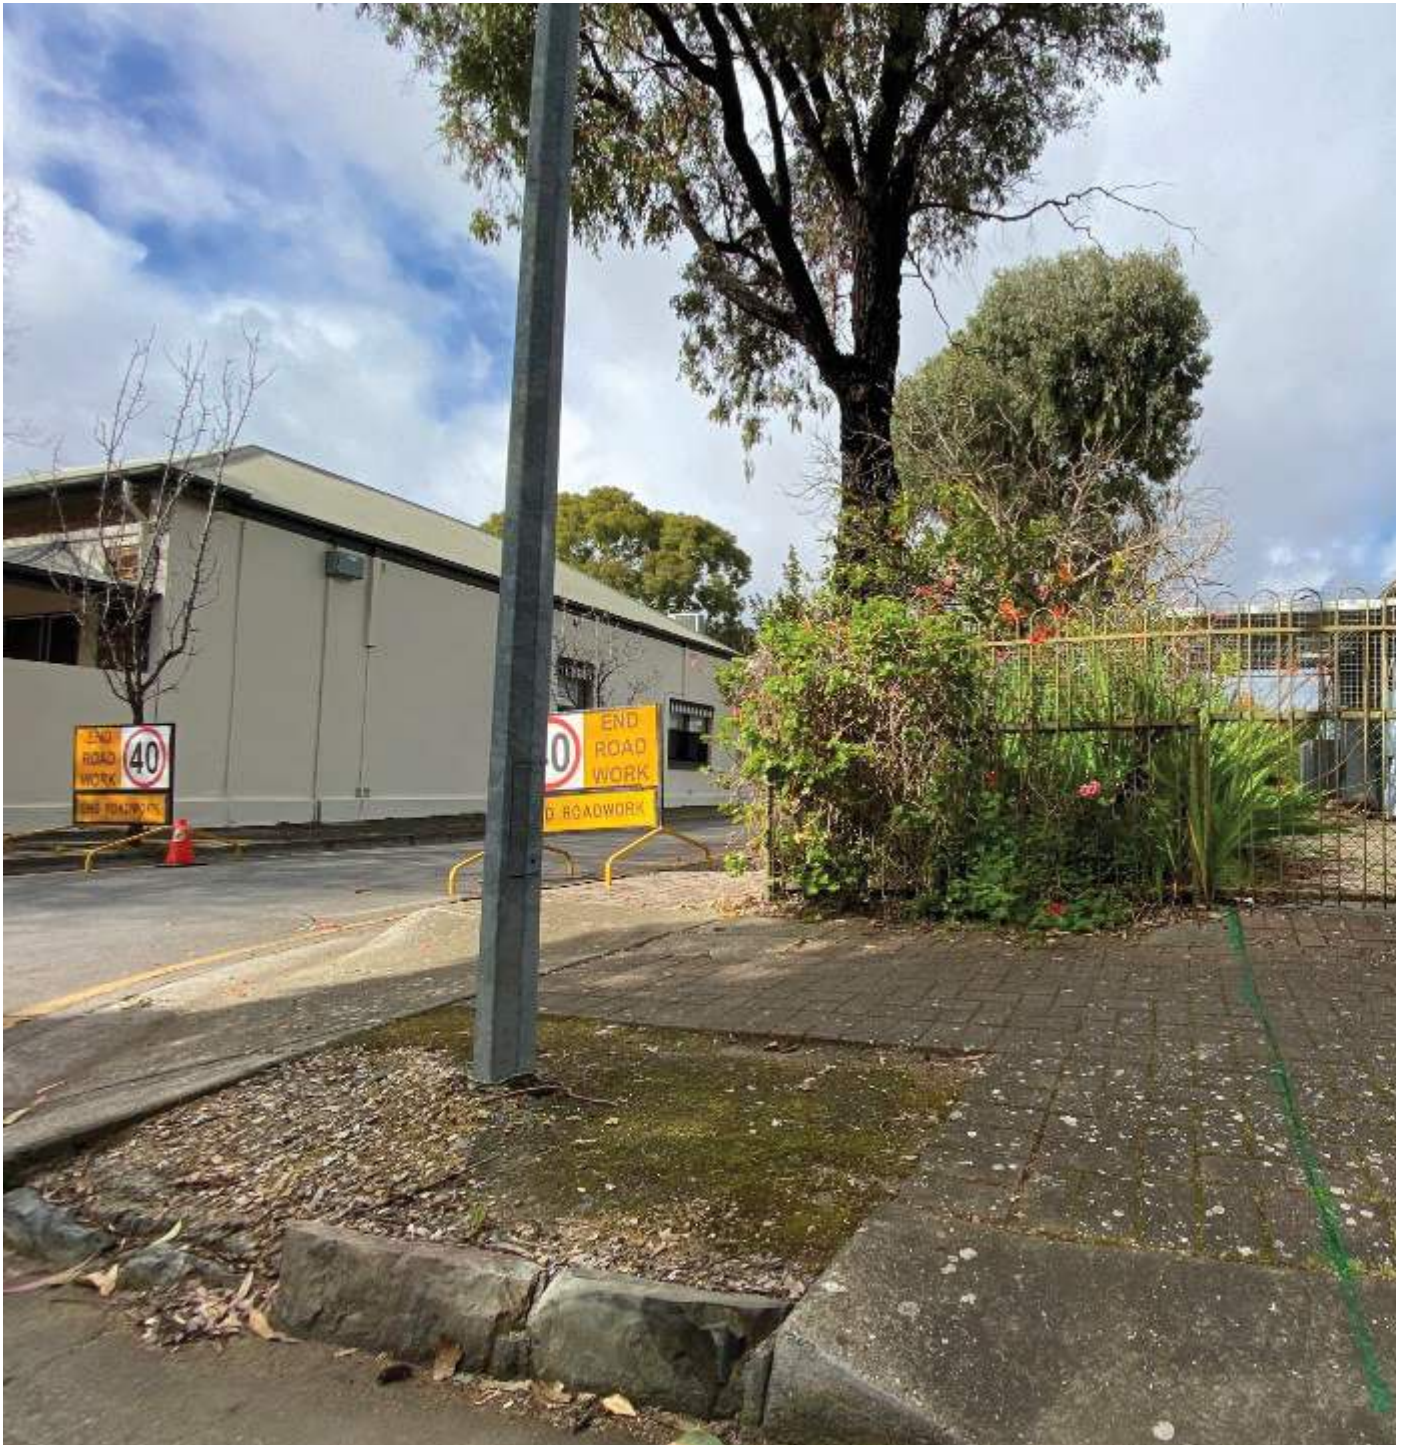
Further to my email below and for my own understanding, I took the below image during the assessment, the green line in the image shows the approximate location of the eastern front walls of both dwellings and the line at which an investigative trench would be dug to the south.

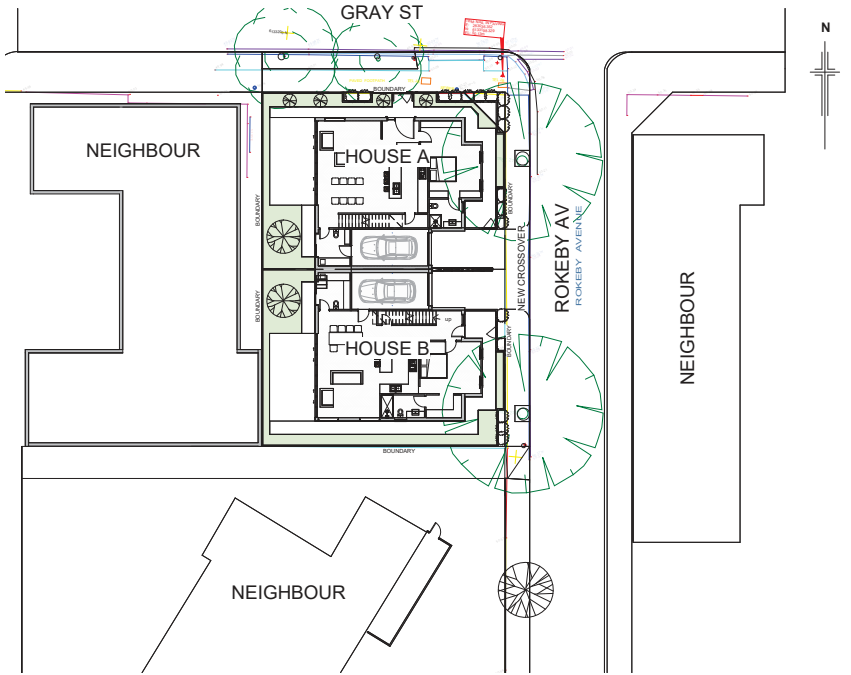
1 LOCATIN PLAN
1 : 200

AREAS	Sq.m		
TOTAL LAND	236	SITE COVERAGE	
		112/236	= 47.8%
GF LIVING	112.9		
FIRST FL LIVING	50.0	PRIVATE OPEN SPACE	
OUTDOOR LIVING	21.4		= 85.0 Sq.m
		LANDSCAPE SPACE	
TOTAL	= 183.9		= 40.0 Sq.m

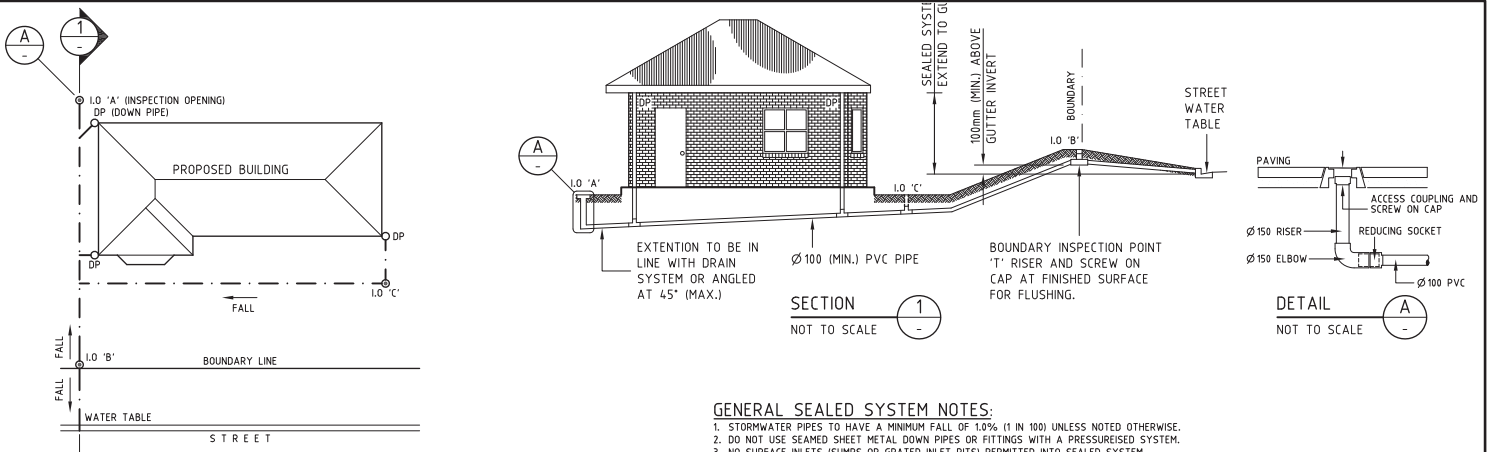
TYPICAL DOMESTIC SEALED (PRESSURISED) DRAINAGE SYSTEM LAYOUT NOT TO SCALE

1. STORMWATER PIPES TO HAVE A MINIMUM FALL OF 1.0% (1 IN 100) UNLESS NOTED OTHERWISE.
2. DO NOT USE SEALED SHEET METAL DOWN PIPES OR FITTINGS WITH A PRESSUREISED SYSTEM.
3. NO SURFACE INLETS (SUMPS OR GRATED INLET PITS) PERMITTED INTO SEALED SYSTEM.
4. PROVIDE LEAF GUARDS AT DOWN PIPE INLETS.
5. FLUSHING AND MAINTENANCE IS THE RESPONSIBILITY OF THE OWNER.

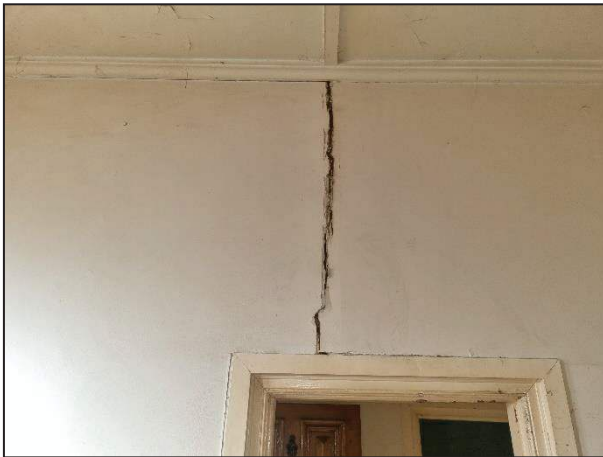
Photo 2 – Severe structural cracking to internal wall

- D. Cracking damage, where visible to some of the internal walls of the residence at the time of inspection, could be classed up to 'severe' or category 4 damage ($> 15.0\text{mm}$) in accordance with AS2870-2011, Appendix C, Table C1.

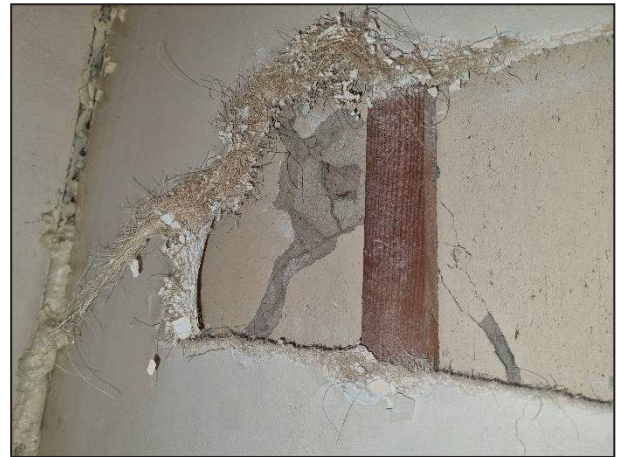
Photo 3 – Cracking to external wall concealed behind fibrous plaster cladding

- E. The most severe internal wall cracking was observed to the north-eastern room, particularly surrounding the north-eastern external corner of the building. Plasterboard internal wall cladding had separated up to 10.0mm . The cracking to the brickwork behind was likely as severe, possibly worse due to masonry's lesser ability to absorb movement.

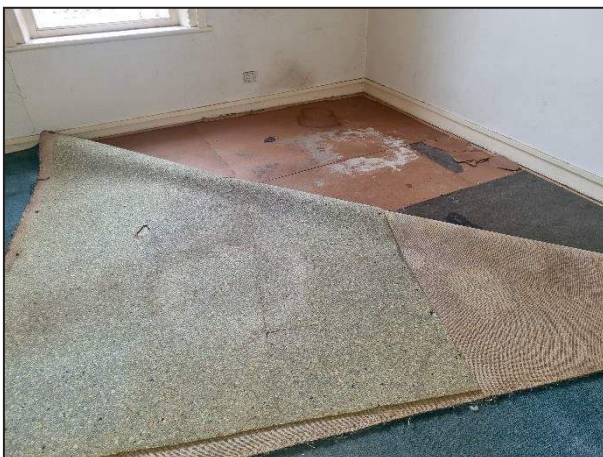
Photo 4 – Dropped floor in south-western room

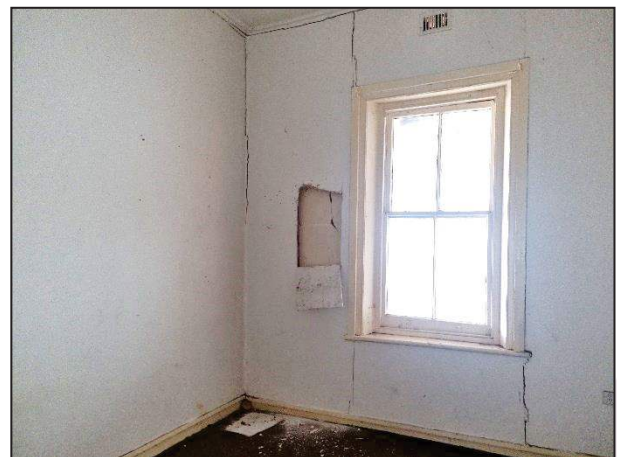
Photo 5 – Typical cracking to internal plasterboard claddings
