Council Assessment Panel Agenda & Reports

plot date:	20/12/2023	status:	PRELIMINARY
scale:	As indicated	client name:	Kathrin, Jessica & Matthew
DD no:	221023	project no:	
drawn by:	JL	PROPOSED RESIDENCE	
checked by:	JA	project address:	10 GRAY ST, NORWOOD
		stage no.:	P100
		drawing title:	GENERAL LOCATION

**ARBORICULTURAL REPORT
DEVELOPMENT IMPACT ASSESSMENT**

14 August + RFI 8 November 2023
Anthony Cirocco Design
10 Gray Street Norwood
tas - 3088

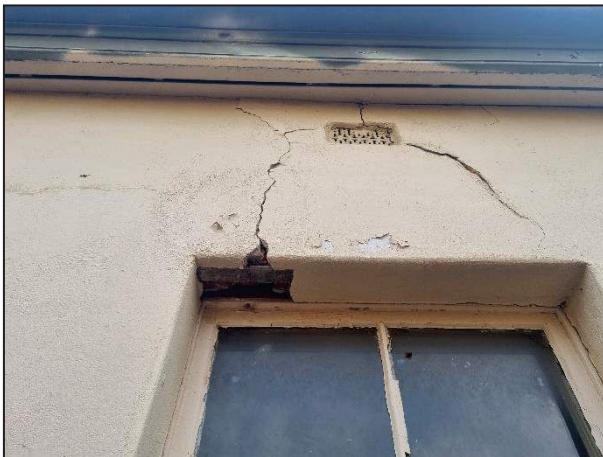
Photo 6 – Structural cracking over lintel on southern external wall

- H. Located at the southern external wall, a steel lintel was noted to have deflected, resulting in cracking of the brickwork above. The glass window was still intact.

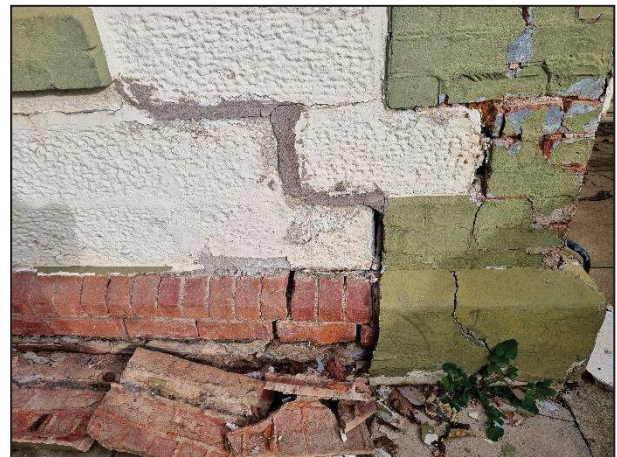
Photo 7 – Structural cracking to northern eastern external walls with evidence of prior crack filling

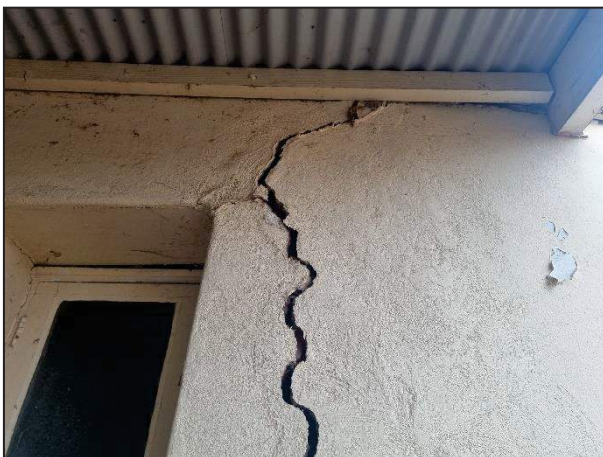
Photo 8 – Structural cracking (Category 4 – Severe) to northern external wall

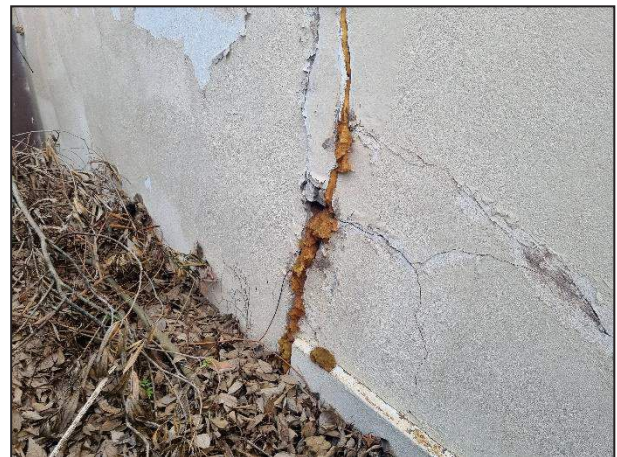
Photo 9 – Structural cracking to southern external wall with evidence of prior gap filling (inadequate)

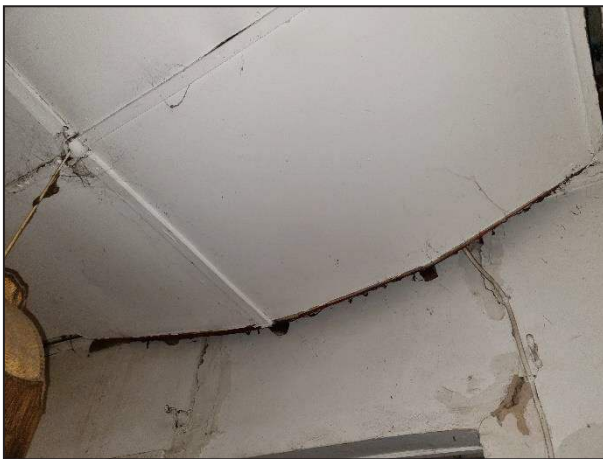
Photo 10 – Collapsed ceiling to rear addition

- F. Roof leaks were evident in multiple locations throughout the residence. Leaks typically were indicated by moisture staining on the floors and ceilings. In the central hallway, a portion of the plaster ceiling had collapsed. There is also likely moisture damage to the ceilings and possibly framing elsewhere.

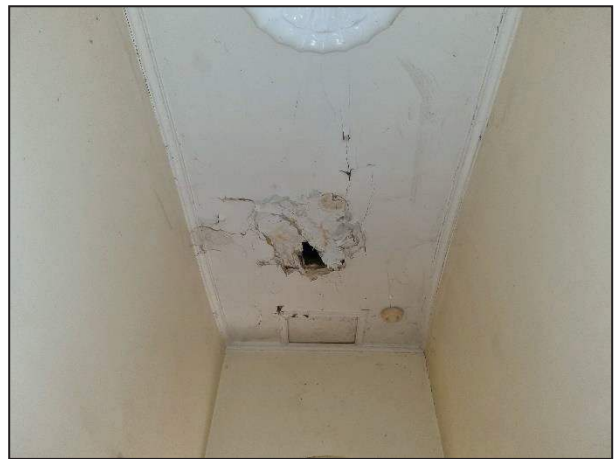
Photo 11 – Collapsed plaster ceiling due to roof leak

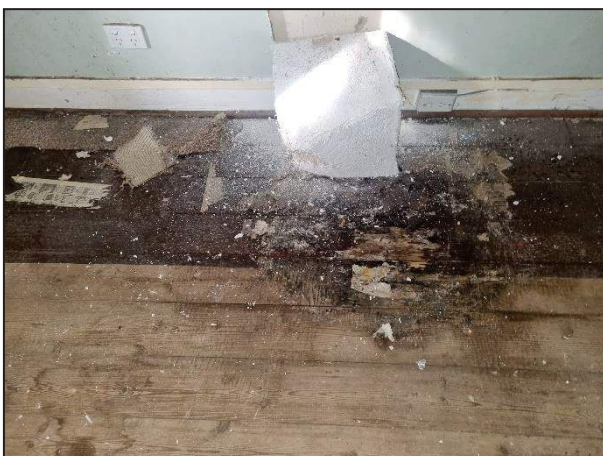
Photo 12 – Moisture damage to timber floorboards due to roof leak above

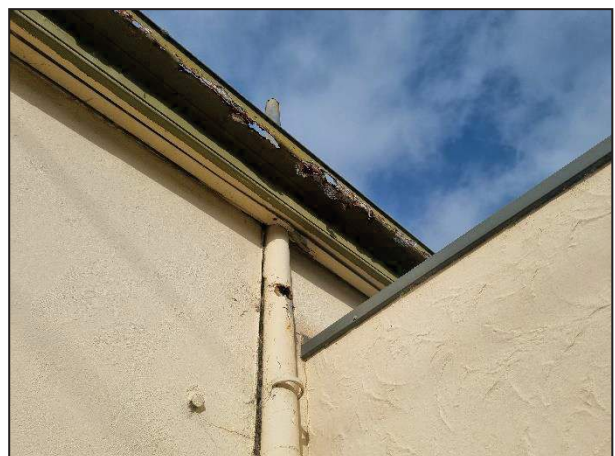
Photo 13 – Corrosion to gutters and downpipes

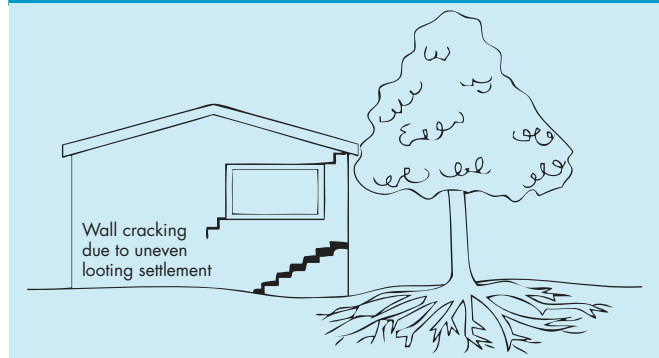
As the weather pattern changes and the soil begins to dry out, the external footings will be first affected, beginning with the locations where the sun's effect is strongest. This has the effect of lowering the

Trees can cause shrinkage and damage

external footings. The doming is accentuated and cracking reduces or disappears where it occurred because of dishing, but other cracks open up. The roof lines may become convex.

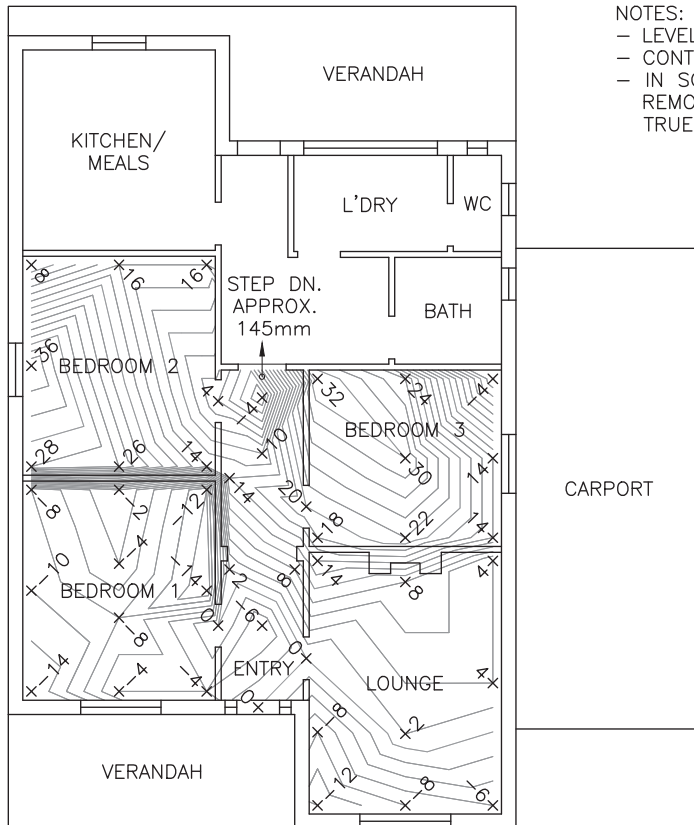
- LEVELS ARE SHOWN IN MILLIMETRES.
- CONTOURS ARE SHOWN AT 2mm INTERVALS.
- IN SOME AREAS THE CARPET WAS WORN OR HAD BEEN REMOVED, AND THE RECORDED LEVELS MAY NOT BE A TRUE REPRESENTATION OF THE TIMBER FLOOR BELOW.

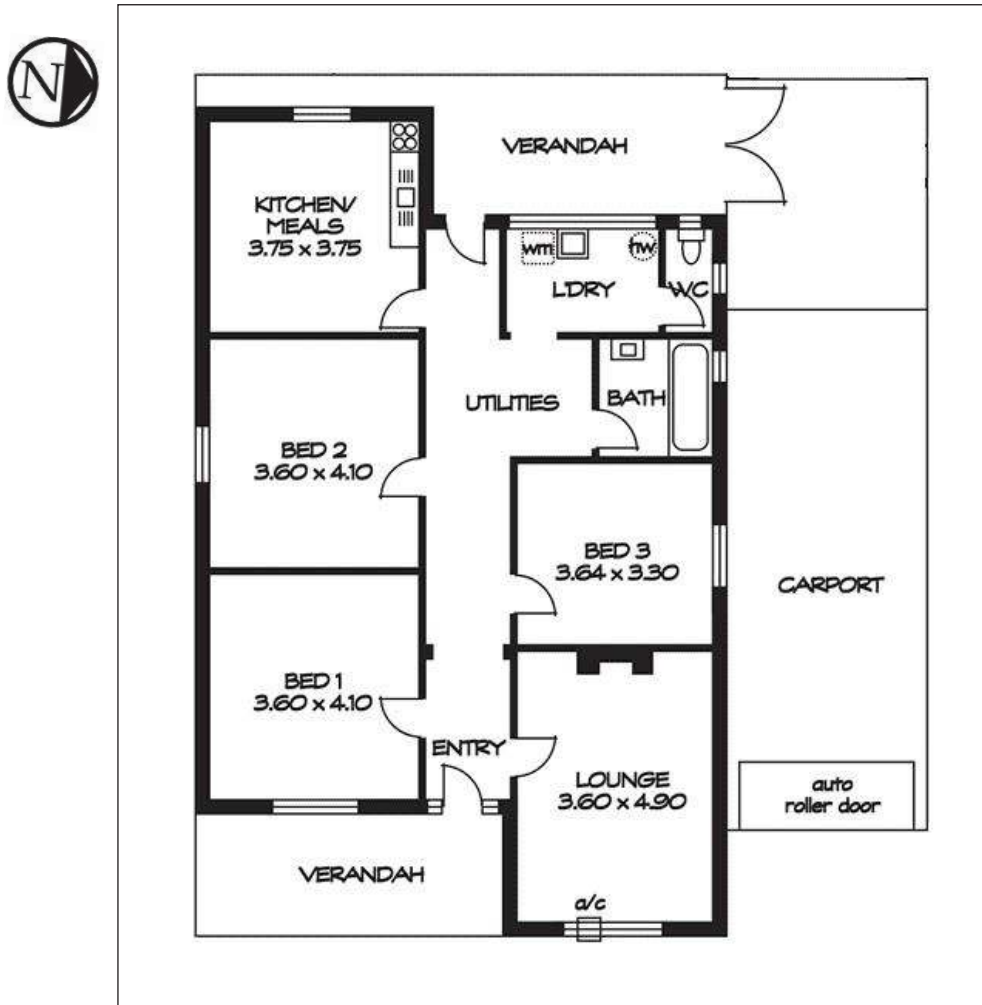
Figure 3. Floor plan of property

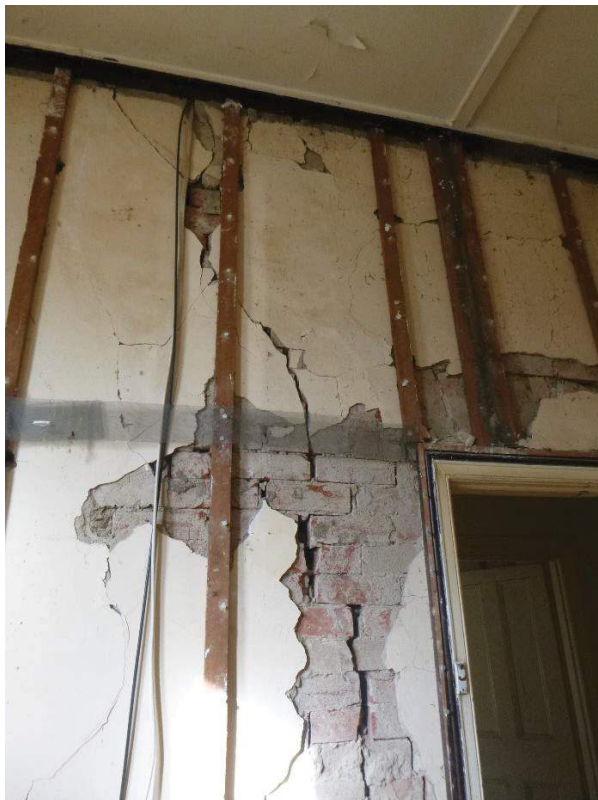
Major cracking – Lounge

- Several cracks in the plaster throughout all walls.
- Cracking along northern and southern cornices.
- The ceiling had collapsed at the western side of the room.
- Severe cracking along eastern cornice towards north-eastern corner of room. A large gap along this cornice had evidently been filled previously.
- Partially patched cracking in northern wall along north-eastern corner of room. The door frame appeared to be distorted at that location.

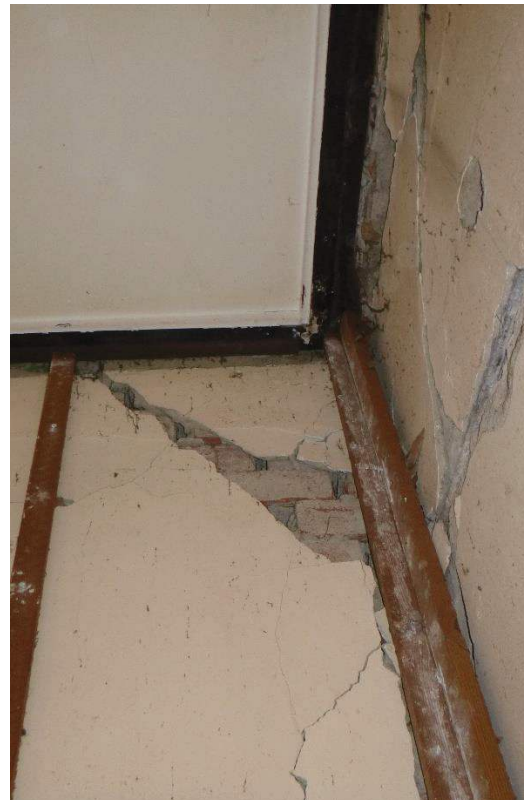
Major cracking – Lounge

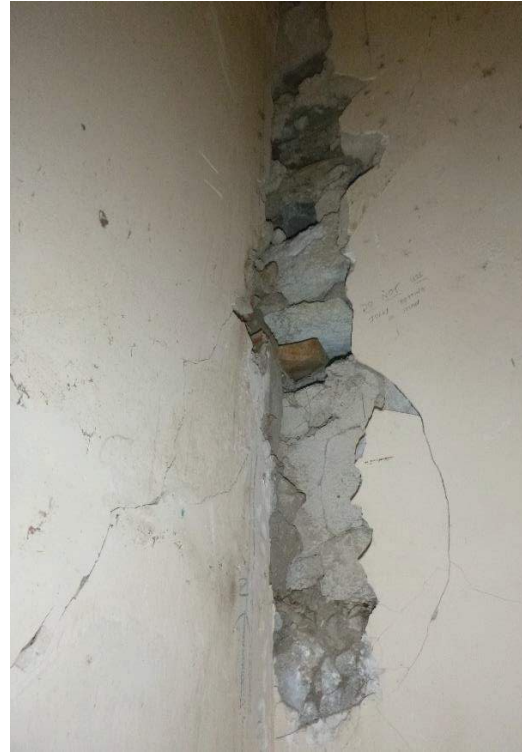
Severe bow in internal wall – Bedroom 1

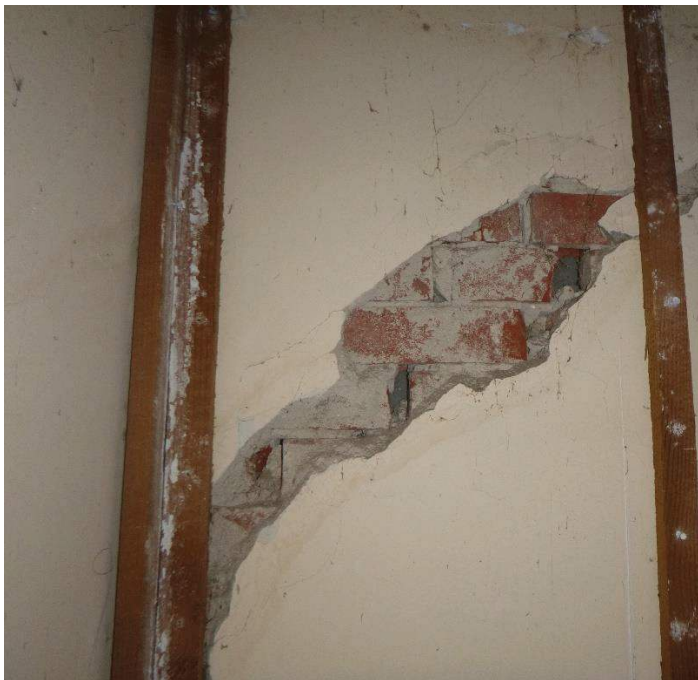
Exposed random rubble construction – Bedroom 1

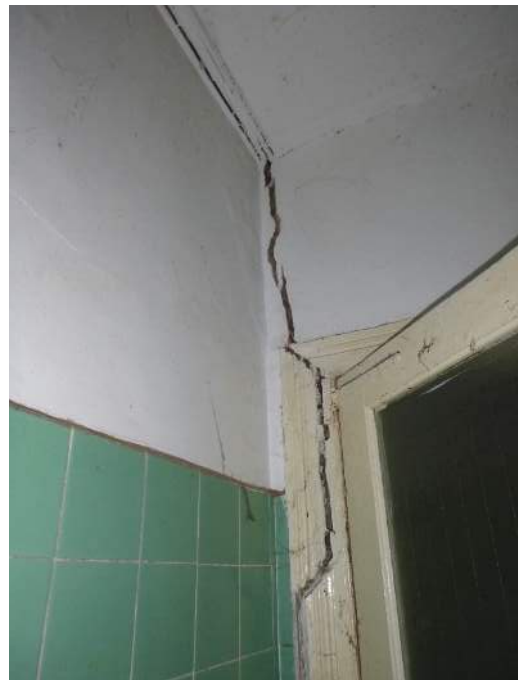
Major cracking – Bedroom 2

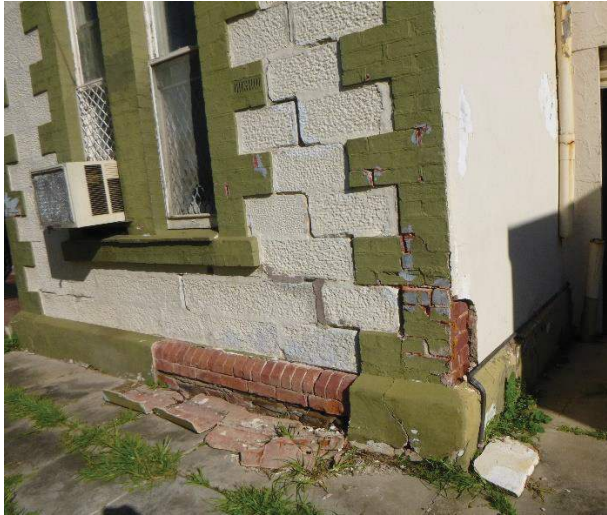
Major cracking and deterioration in north-eastern corner

- Cracking in the render to the footing/brickwork plinth throughout.
- The render had broken away from the footing/brickwork plinth adjacent the north-eastern corner of the house, and exposed deteriorated brickwork and mortar.
- Severe cracks up to 30mm wide in the stone/brickwork/mortar/render towards the north-eastern corner.
- Broken out render around the north-eastern corner of the building revealed, with heavily deteriorated brickwork and mortar.
- Cracking in the face stone and brick quoins throughout.
- Severe deterioration of the masonry/mortar/render around the south-eastern corner of the building. A large section of render had evidently been replaced in this corner, but appeared to be de-bonding again.

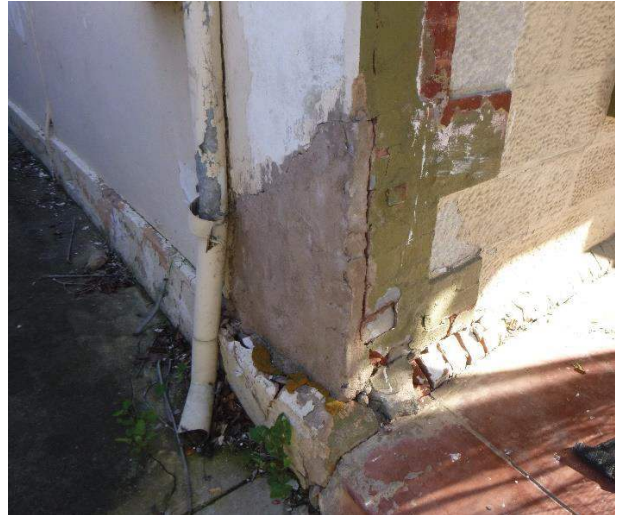
Severe deterioration in south-eastern corner

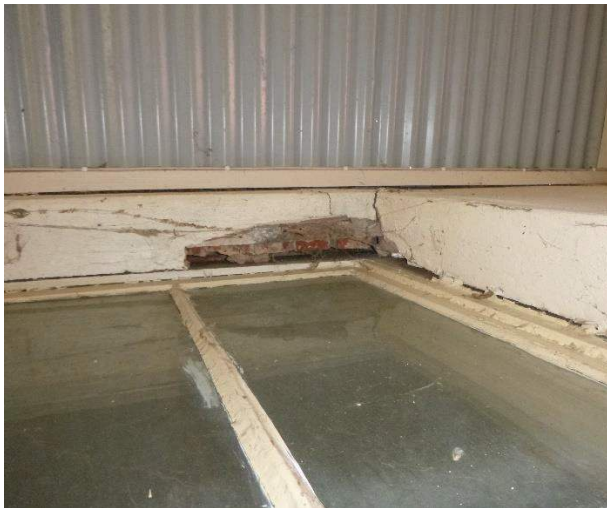
Severe deterioration of brickwork above bedroom 3 window

- Major vertical crack in the masonry between the main house and the lean-to structure.
- Cracking in the render to the footing/brickwork plinth throughout.
- Several cracks and broken out render around the bedroom 3 window.
- The masonry above the lintel to the bedroom 3 window was partly exposed and showed heavily deteriorated brickwork and mortar.

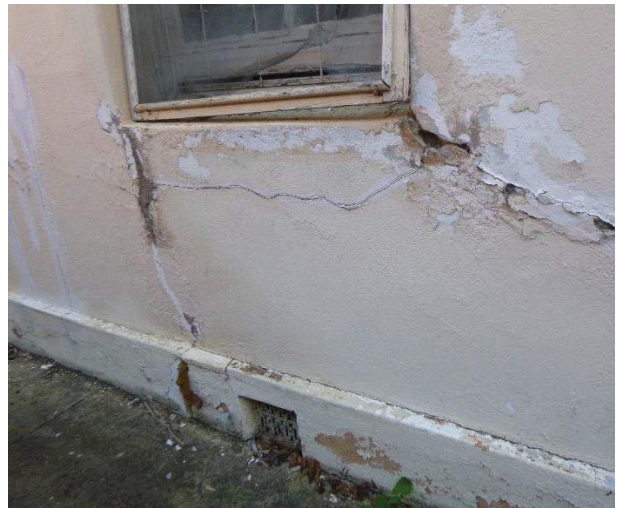
Severe cracking around bedroom 2 window

- Major vertical crack in the masonry between the main house and the lean-to structure.
- Cracking in the render to the footing/brickwork plinth throughout.
- Paint peeling from the render throughout.
- Severe cracking and broken out render with some previous patching around the bedroom 2 window.
- The masonry above the lintel to the bedroom 2 window was partly exposed and showed heavily deteriorated brickwork and mortar.

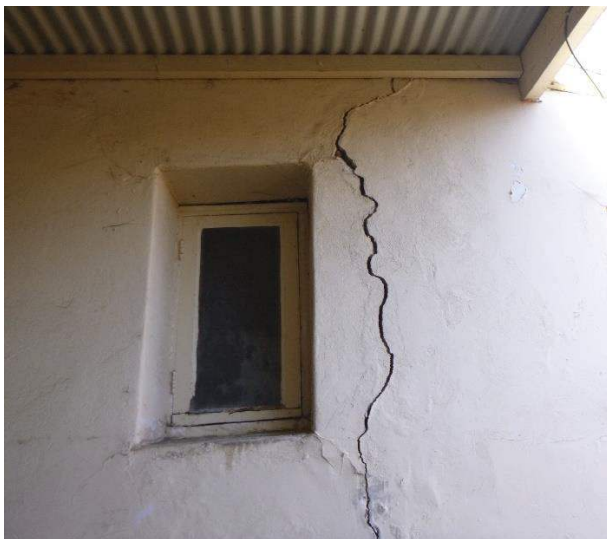
Major cracking between main house and lean-to

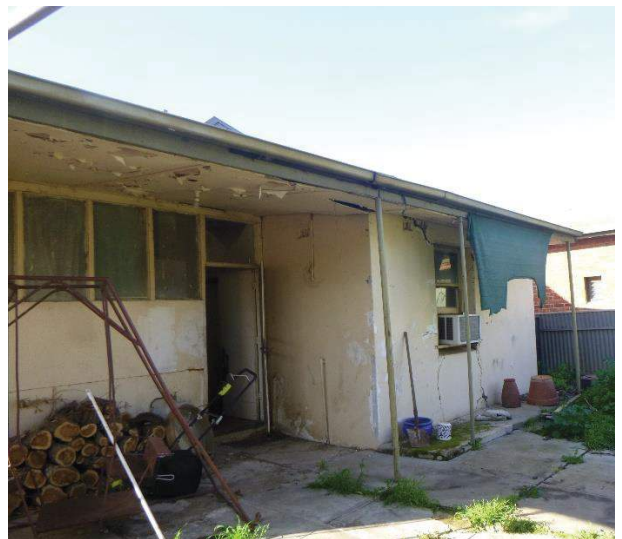
Lean-to construction at rear

- The lean-to structure was deteriorated and showed severe cracking and damage throughout.
- No details were recorded on this side of the house, as the lean-to is proposed to be demolished.

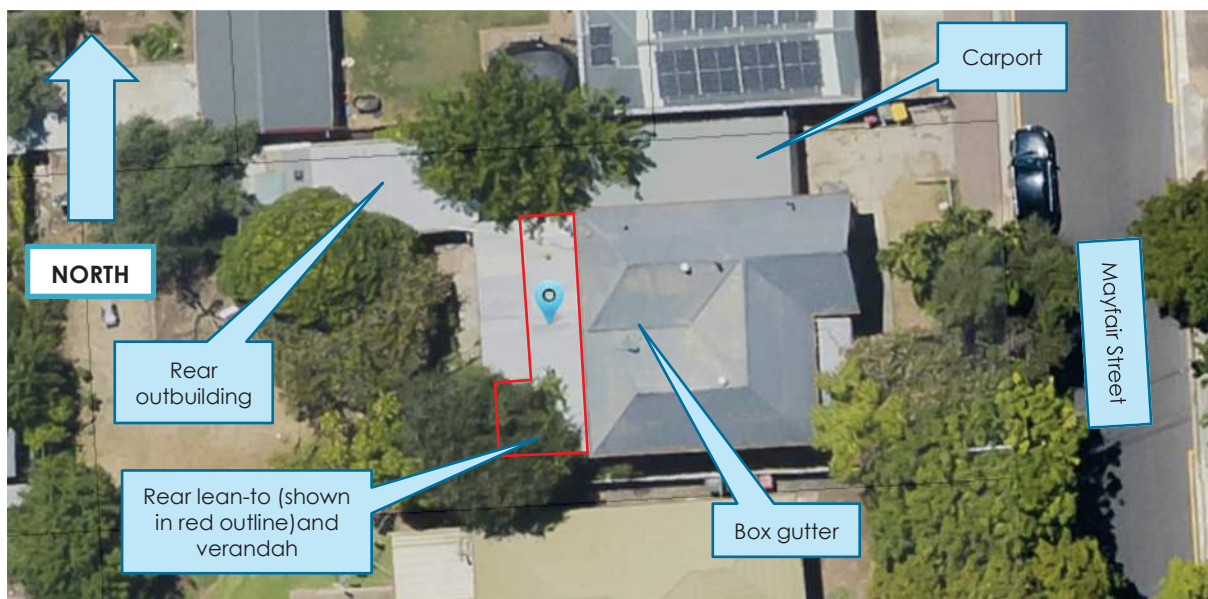
Figure 1 – Aerial image of site from the SA Property and Planning Atlas

The single storey building is of masonry construction with timber floors and bluestone strip footings, and faces east onto Mayfair Street. The steel sheet roof is conventionally timber framed and is 'M-shaped' at the rear, forming a box gutter above the central area of the building (refer Figure 1). The wet areas and rear lean-to have concrete slab floors. The internal walls are clad with fibrous plaster supported on battens.

The roof stormwater discharges into downpipes. The downpipe at the south-eastern corner (collecting the southern catchment) discharges onto the bath directly below it. The northern catchment discharges to the Mayfair Street footpath via a flying downpipe. The rear catchment of the original roof discharges via a flying downpipe toward the rear outbuilding. The rear lean-to / verandah catchment discharges via a downpipe buried beneath mulch (it is unclear where this downpipe discharges). The condition of any sub-surface pipework (including stormwater and sewer) is unknown. The building is surrounded by several trees and other vegetation, as shown on Figure 1.

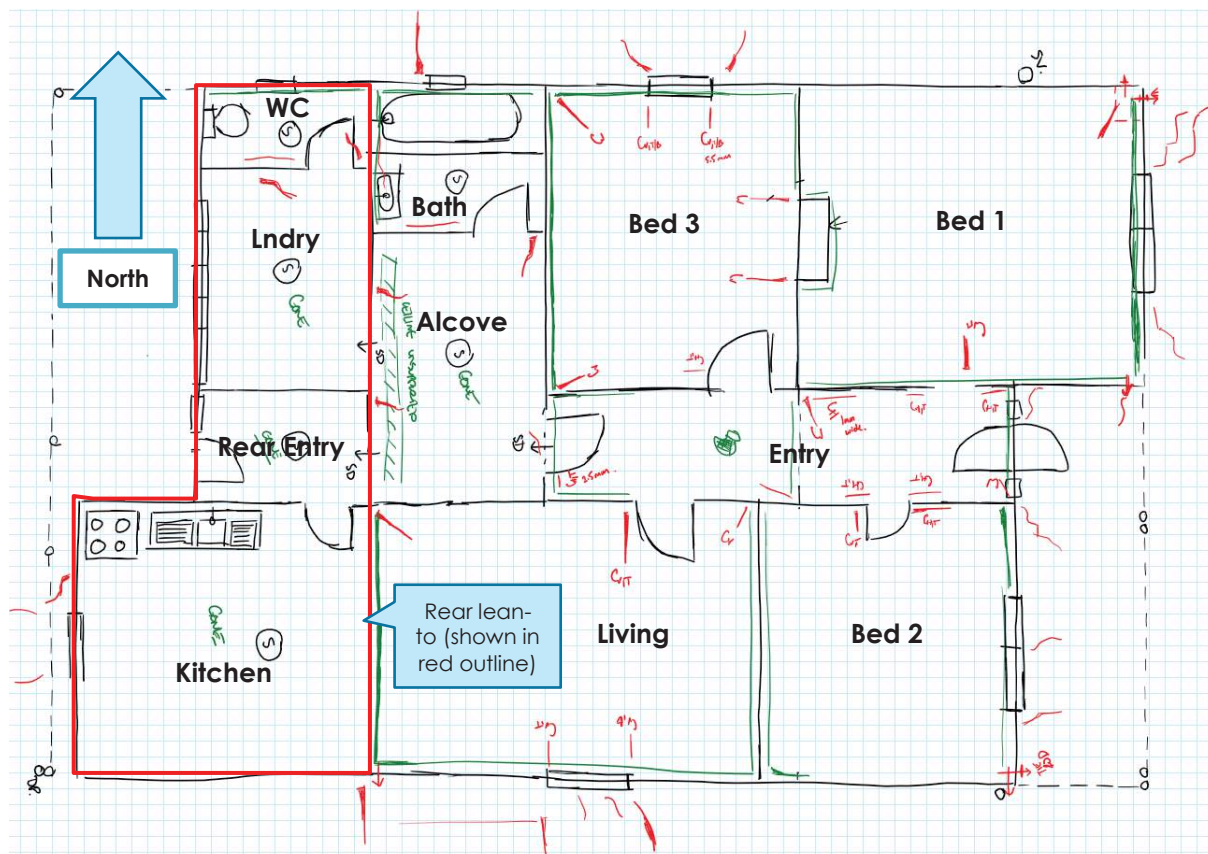
Figure 2 – Red is damage to walls, green is damage to ceilings & cornices, blue is damage to floors, yellow highlighting indicate the most severe settlement that may require structural correction

Due to the number of instances of damage identified, we have not included each in our report. We have included the most significant items for your consideration. We have included a copy of our site notes, which shows the instances of internal damage marked up on a floor plan of the building, as Figure 2 below. Should a more comprehensive catalogue of cracking be required, we would be pleased to provide it upon receipt of your further instructions.

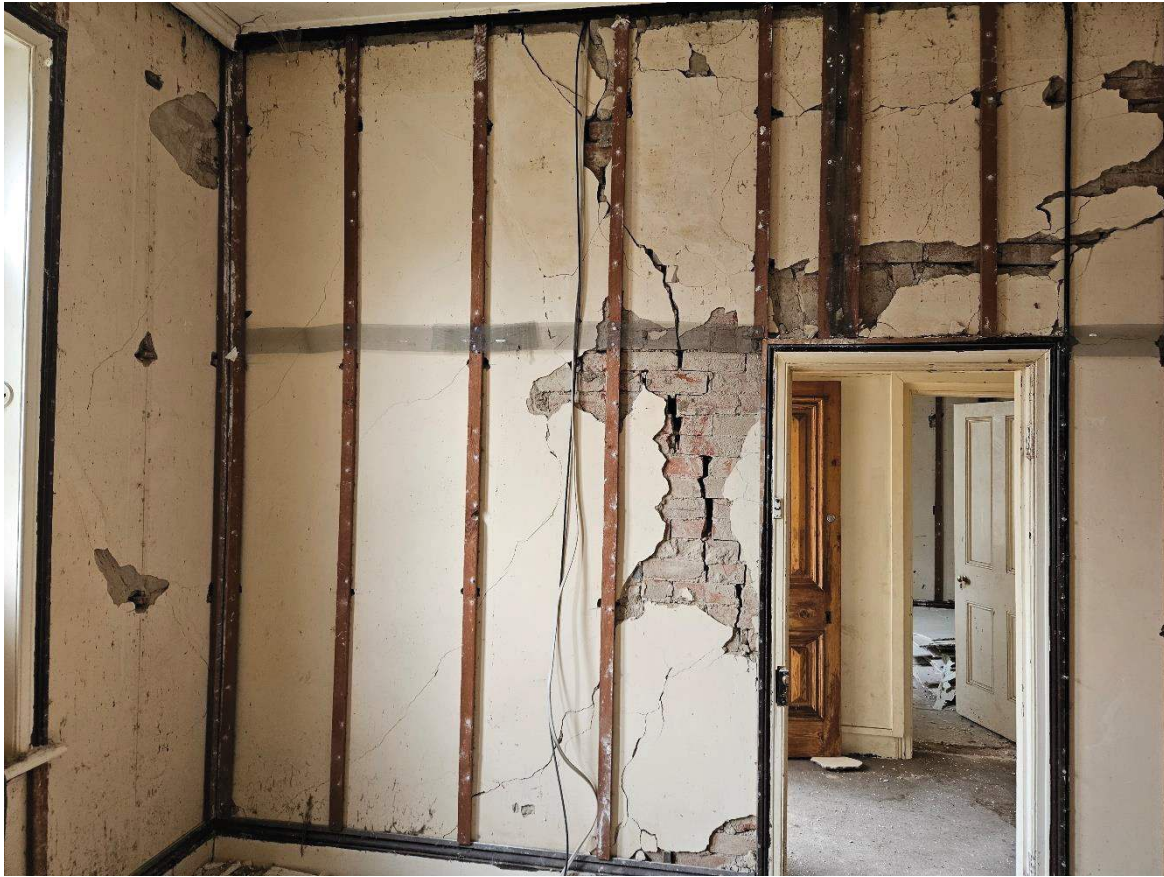
Photo 1 – Bed 1 southern wall (shared with entry)

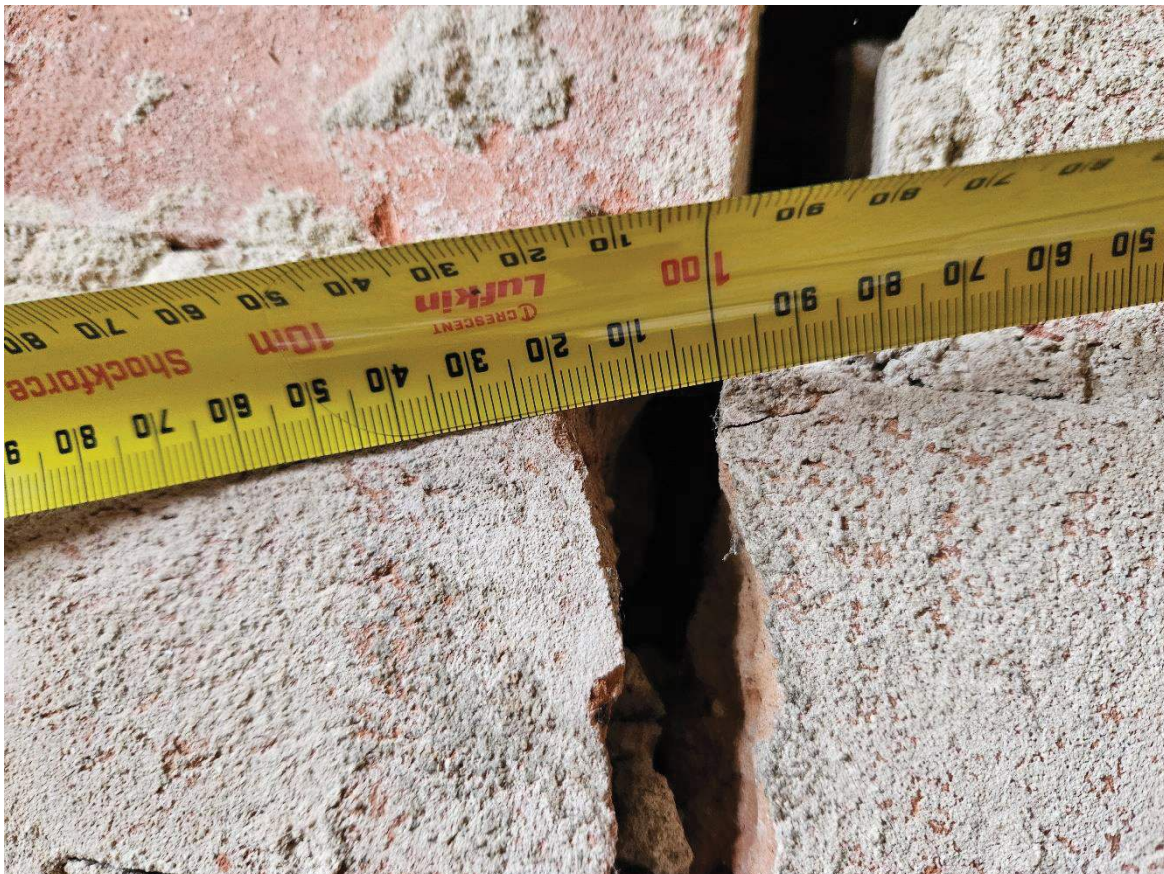
Photo 2 – Close up of crackingshown in Photo 1

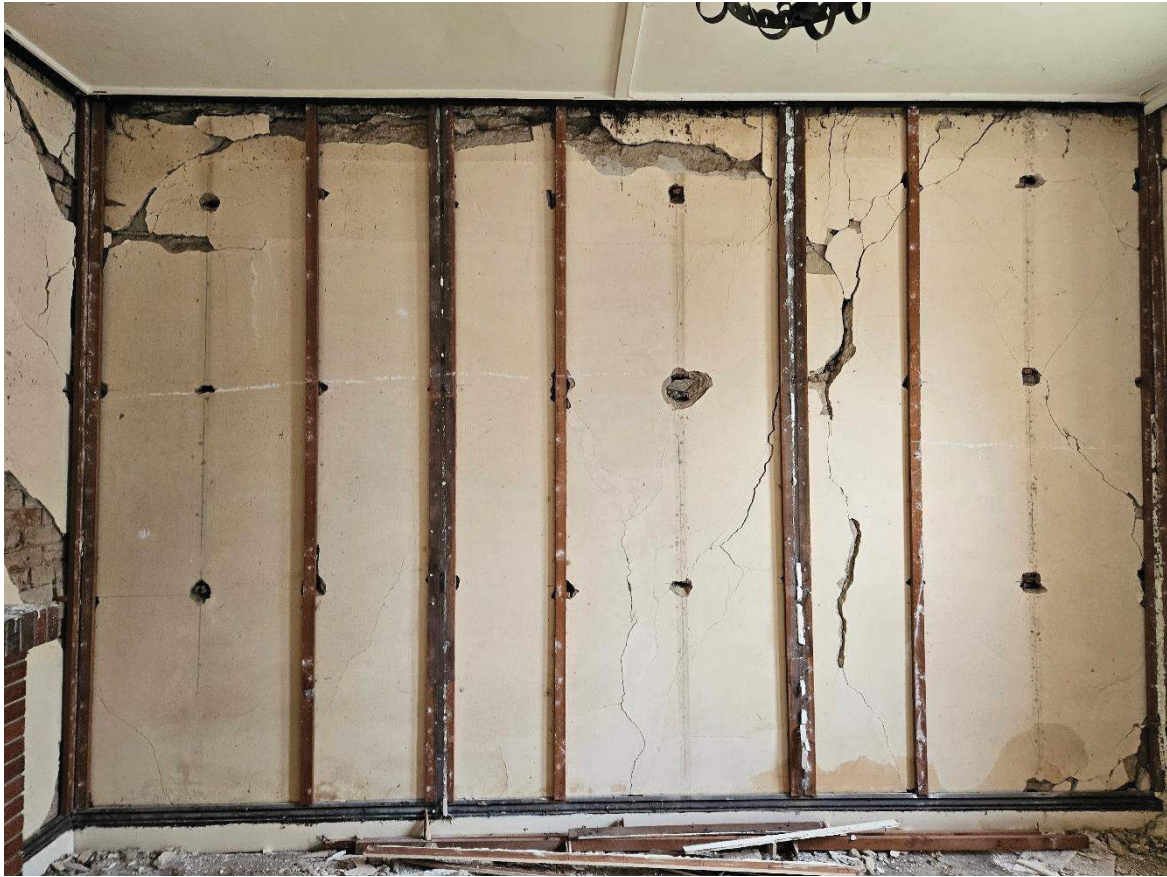
Photo 3 – Bed 1's northern wall

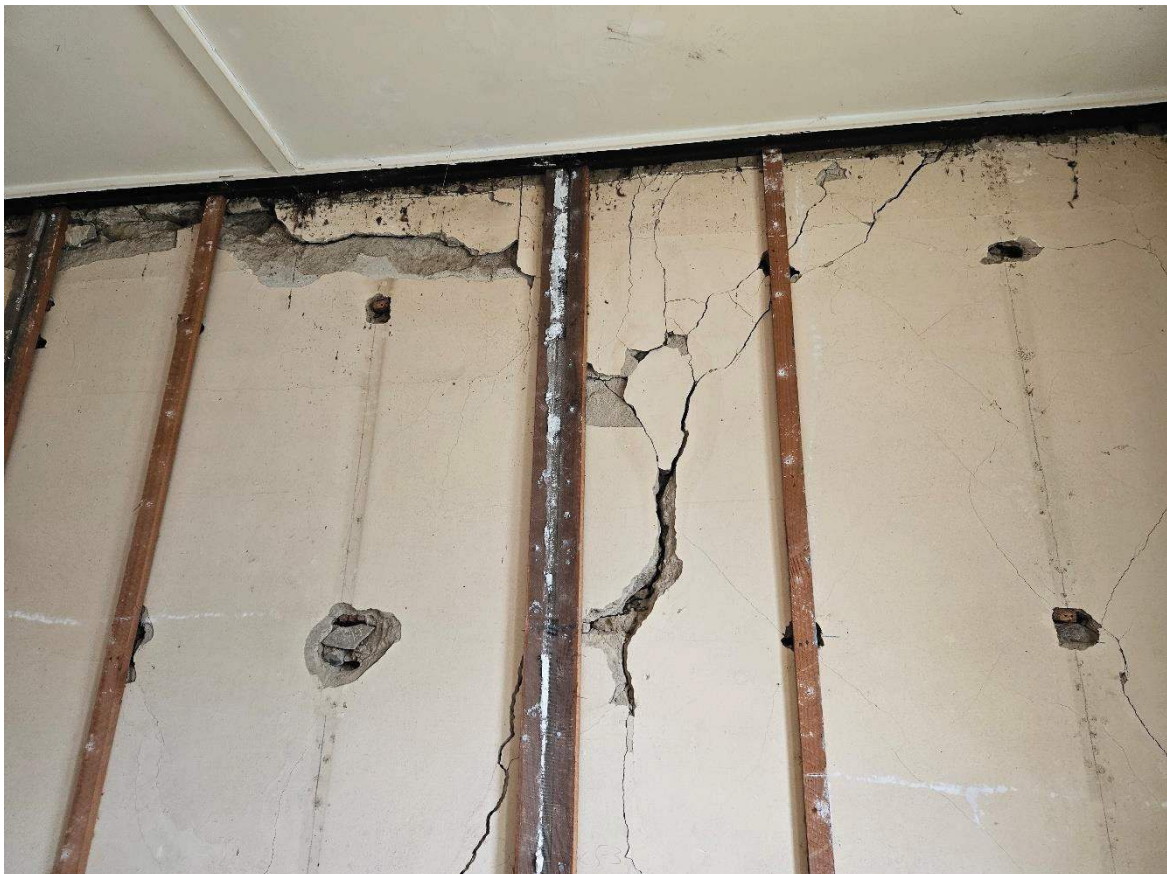
Photo 4 – Bed 1's northern wall

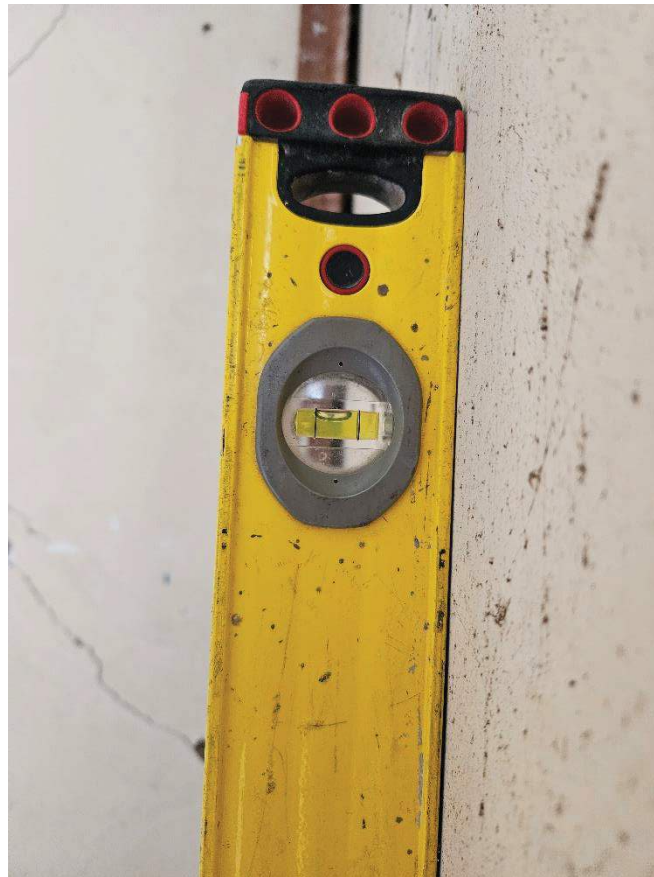
Photo 5 – Rotation of Bed 1's eastern wall

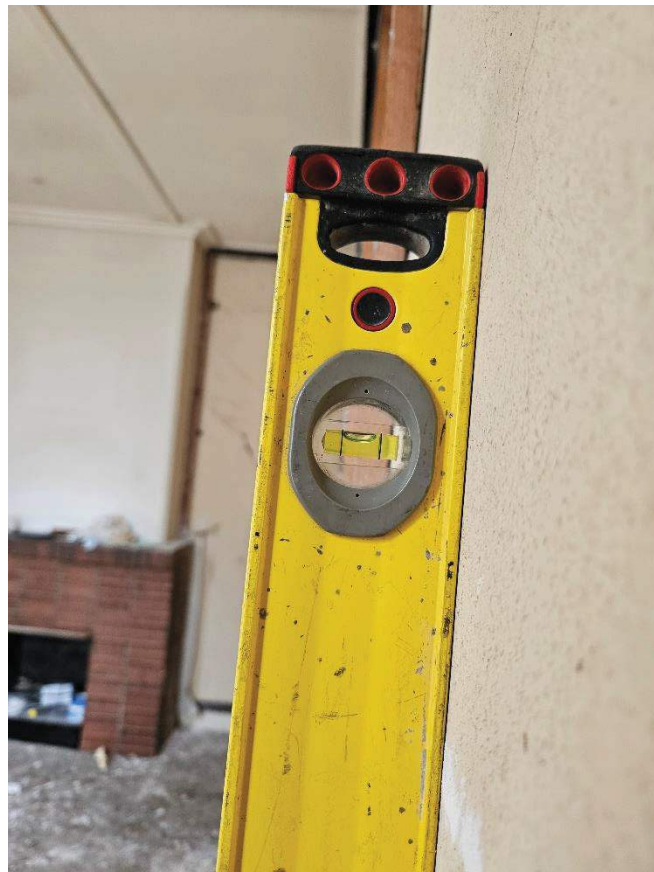
Photo 6 – Rotation of Bed 1's northern wall

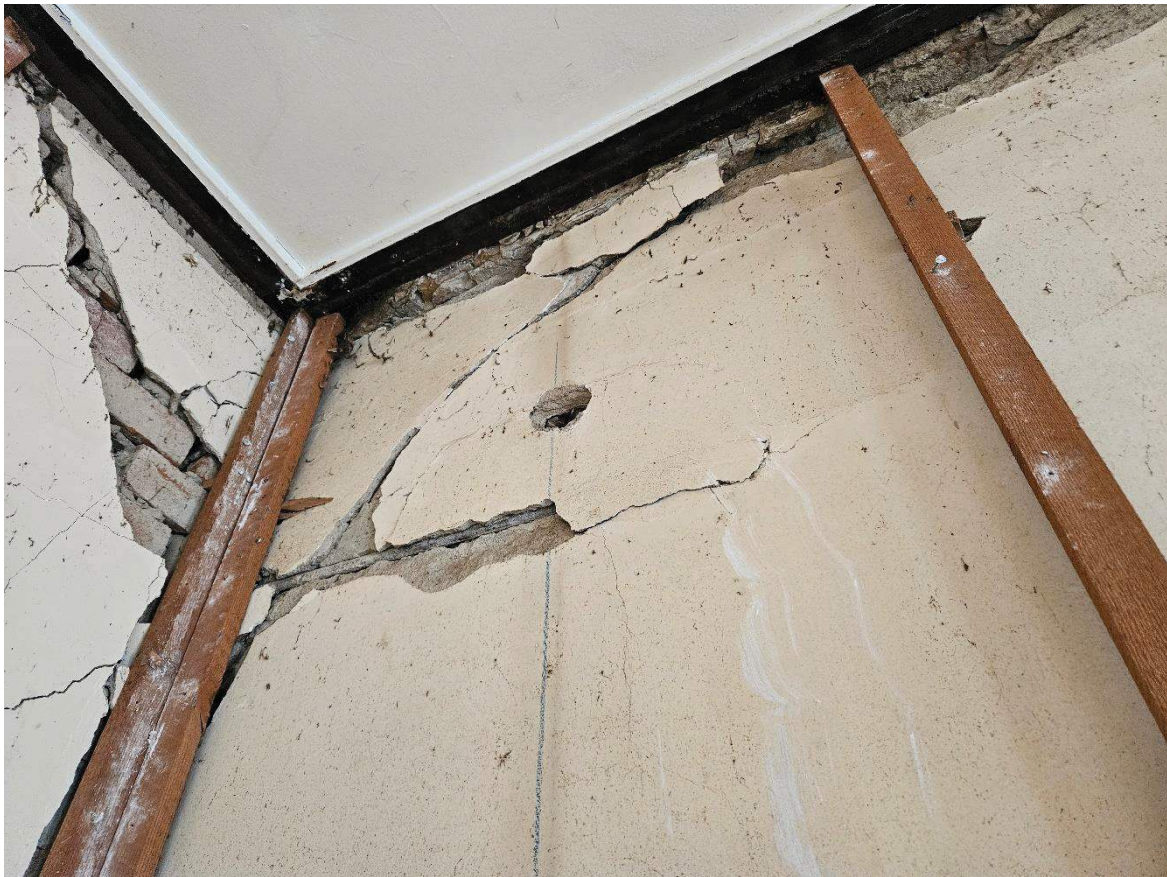
Photo 7 – Tie-rod chased into northern wall of Bed 1, distortion to walls and deterioration of plaster

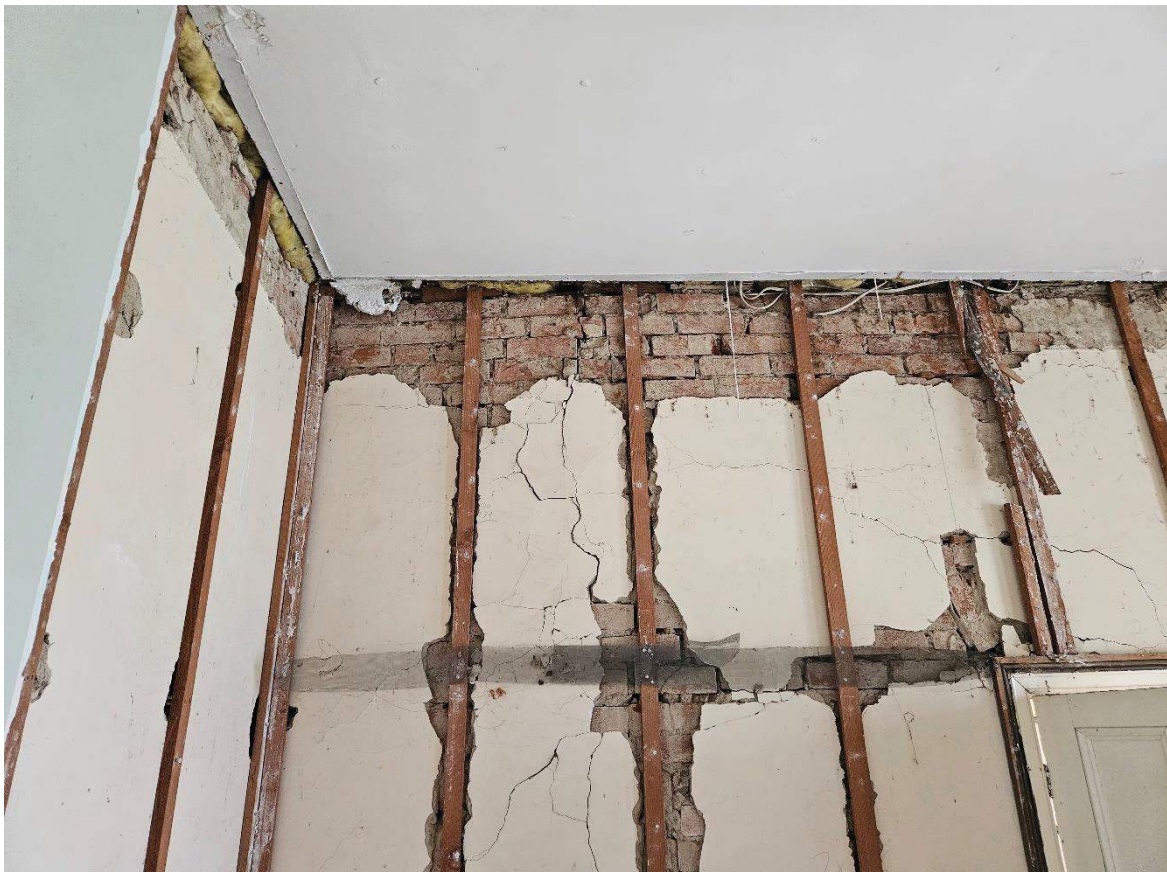
Photo 8 – Bed 2's northern wall, brickwork to top half of wall requires reconstruction

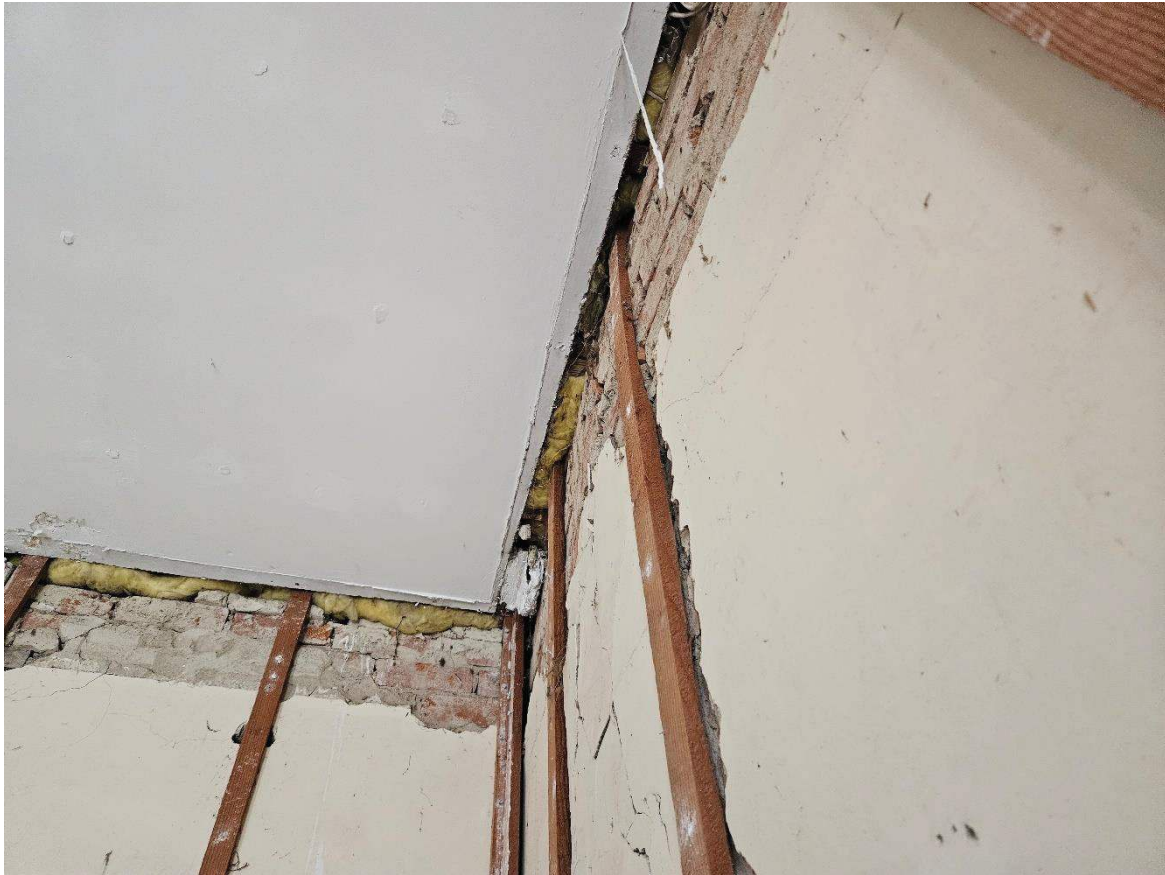
Photo 9 – View of northern Bed 2 wall showing out of plane movement

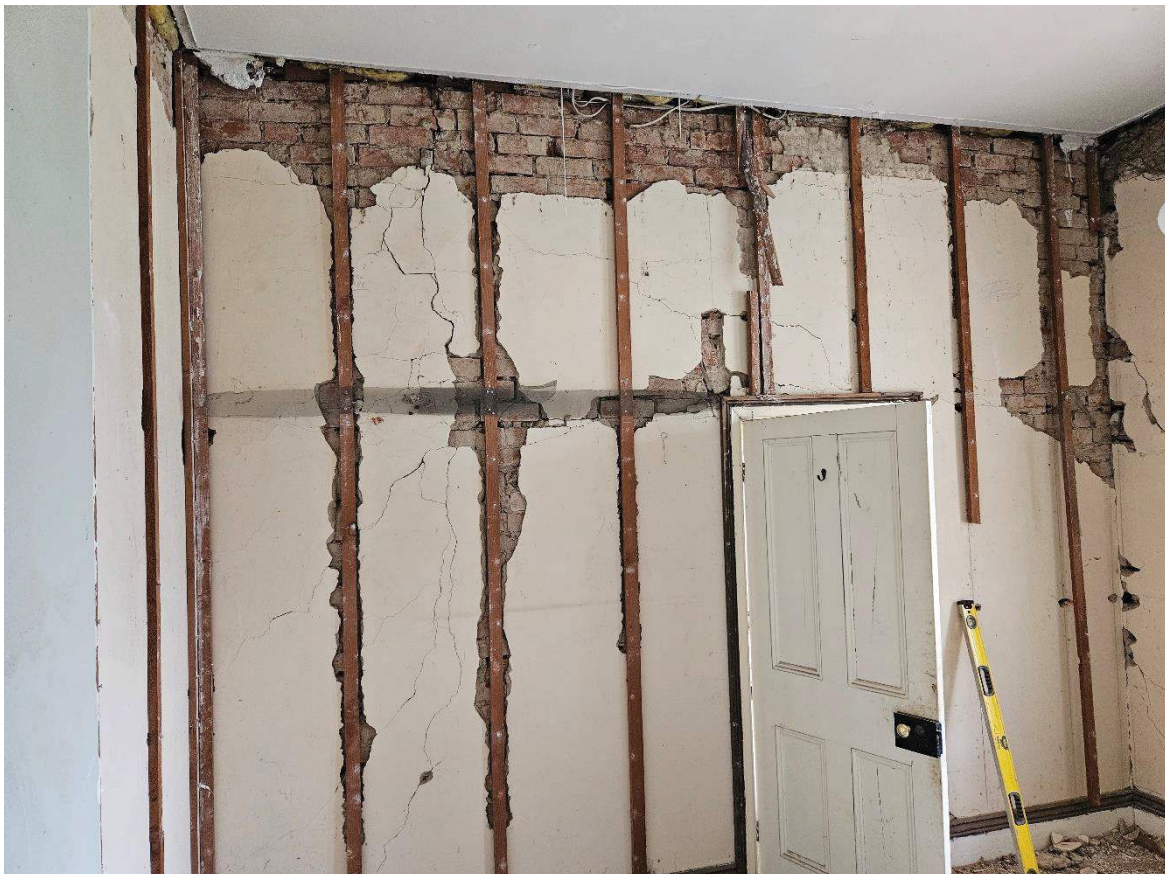
Photo 10 – Overall view of Bed 2's northern wall showing condition of plaster

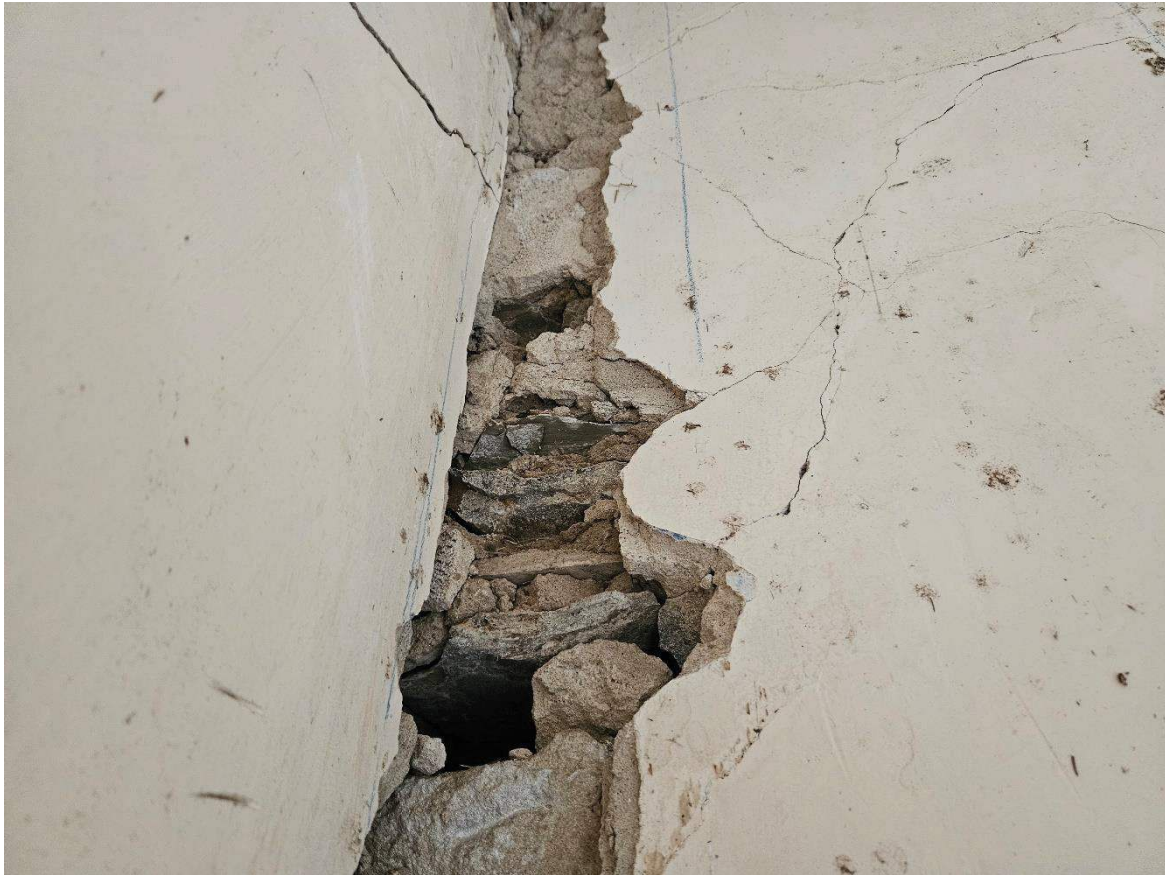
Photo 11 – Internal view of external wall showing random stone masonry construction

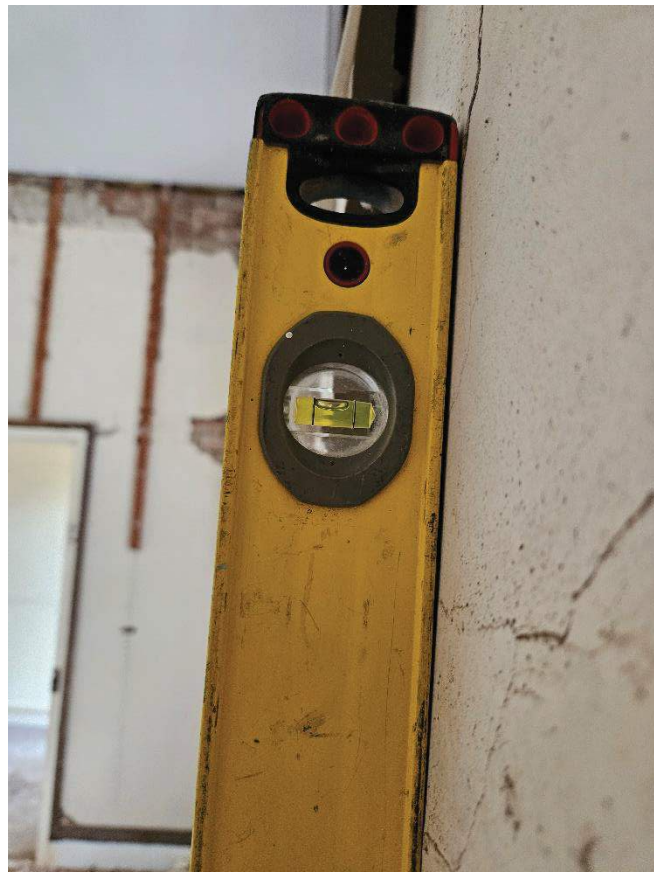
Photo 12 – Rotation of Bed 2's eastern wall consistent with long-term settlement towards east
