Council Assessment Panel Agenda & Reports

plot date:	20/12/2023	status:	PRELIMINARY
scale:	As indicated	client name:	Kathrin, Jessica & Matthew
DD no:	221023	project no:	
drawn by:	JL	PROPOSED RESIDENCE	
checked by:	JA	project address:	10 GRAY ST, NORWOOD
		stage no.:	P100
		drawing title:	GENERAL LOCATION

**ARBORICULTURAL REPORT
DEVELOPMENT IMPACT ASSESSMENT**

14 August + RFI 8 November 2023
Anthony Cirocco Design
10 Gray Street Norwood
tas - 3088

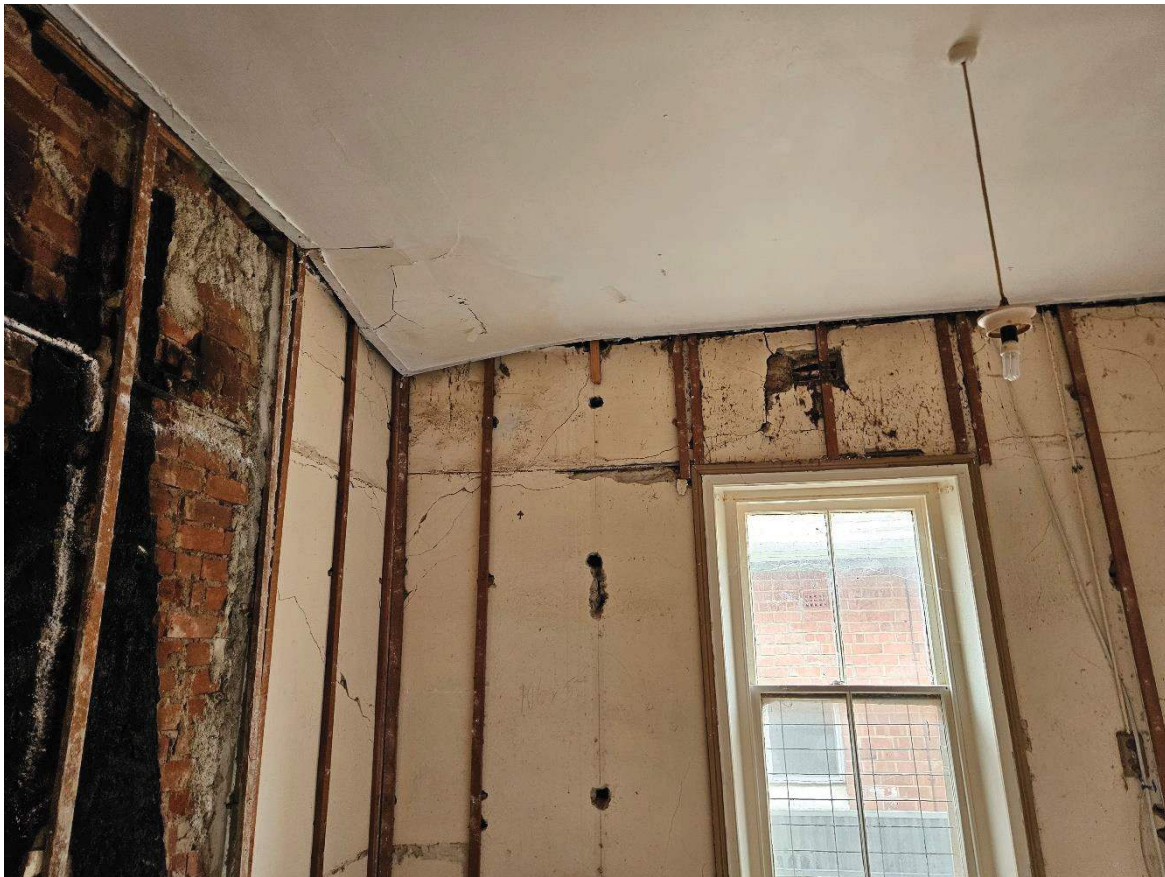
Photo 13 – Living room's ceiling has detached from frame in south-eastern corner

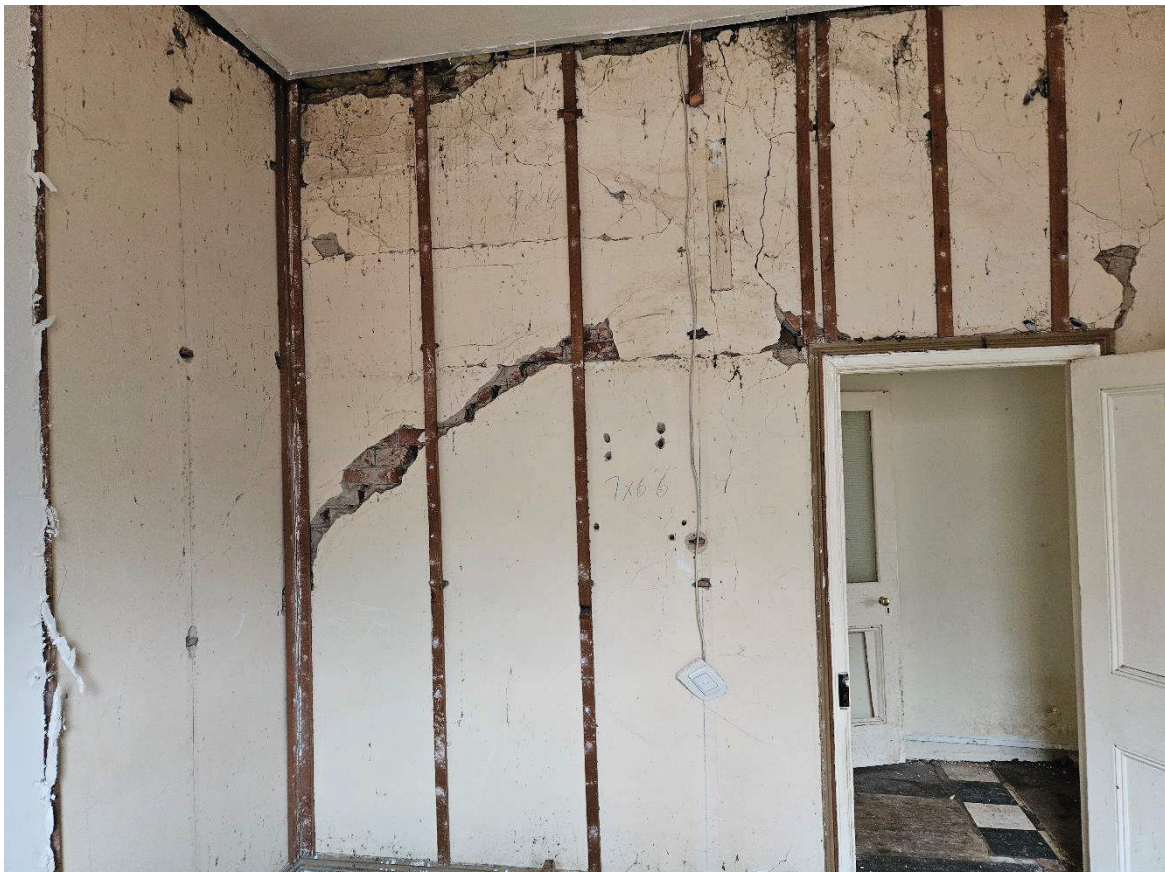
Photo 14 – Overall view of living room's northern wall

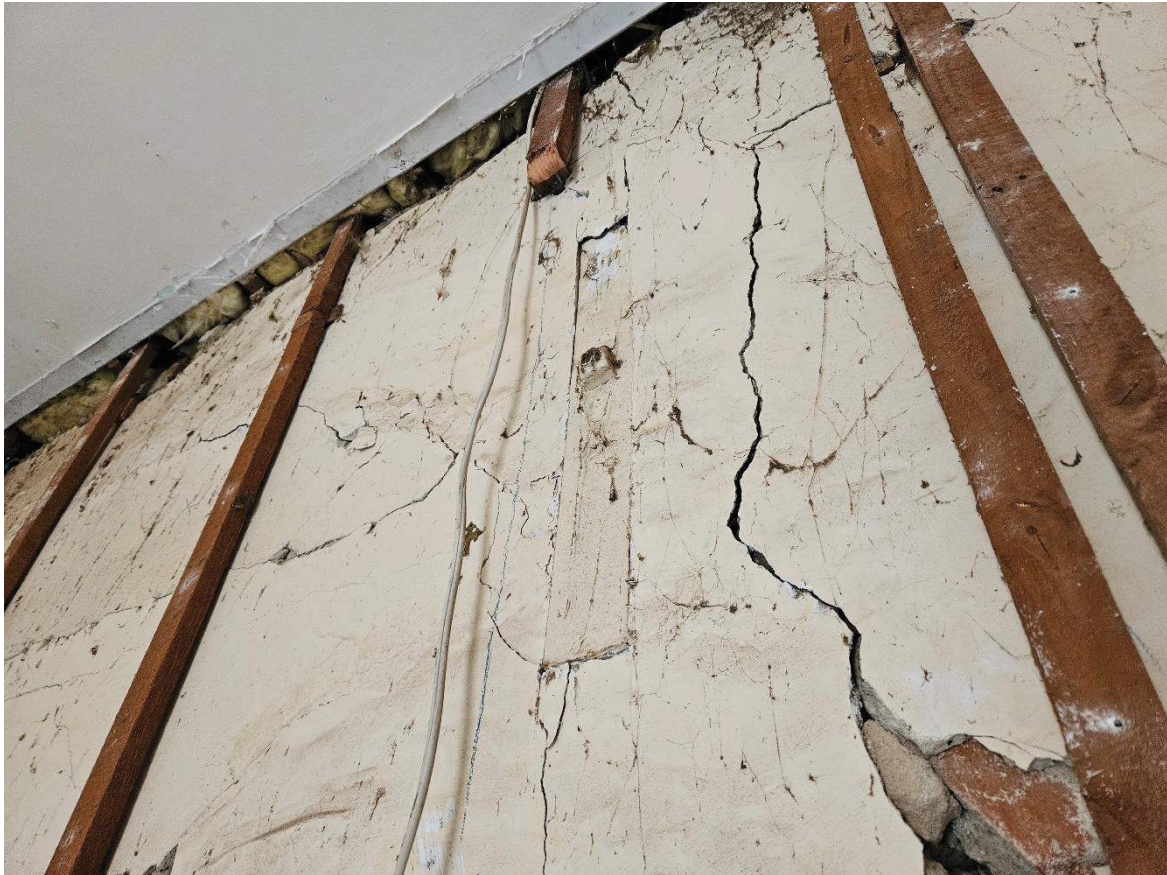
Photo 15 – Tie rod end plate in Living room's northern wall, rotation of brickwork around end plate

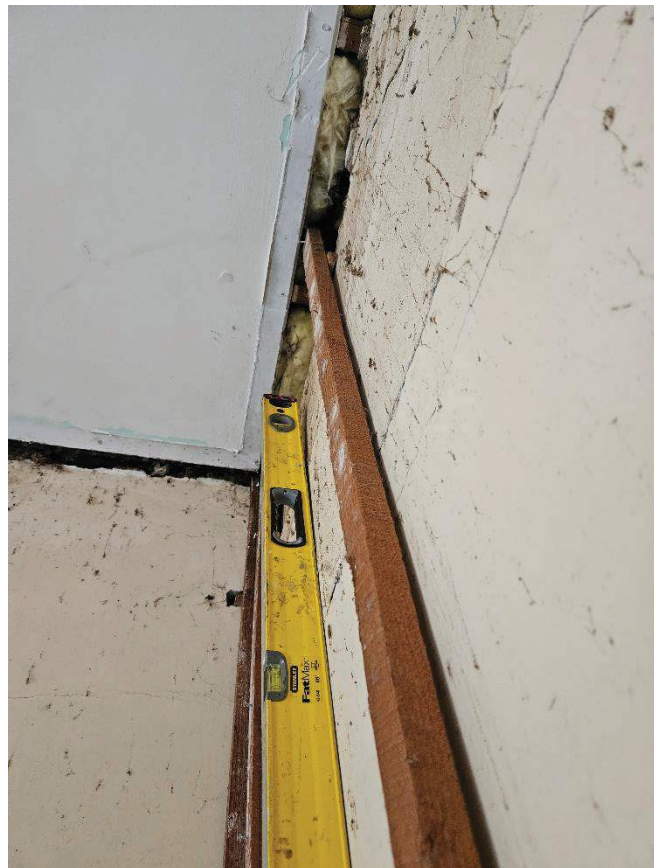
Photo 16 – Gap between straight edge and living room's northern wall shows distortion to top brick courses

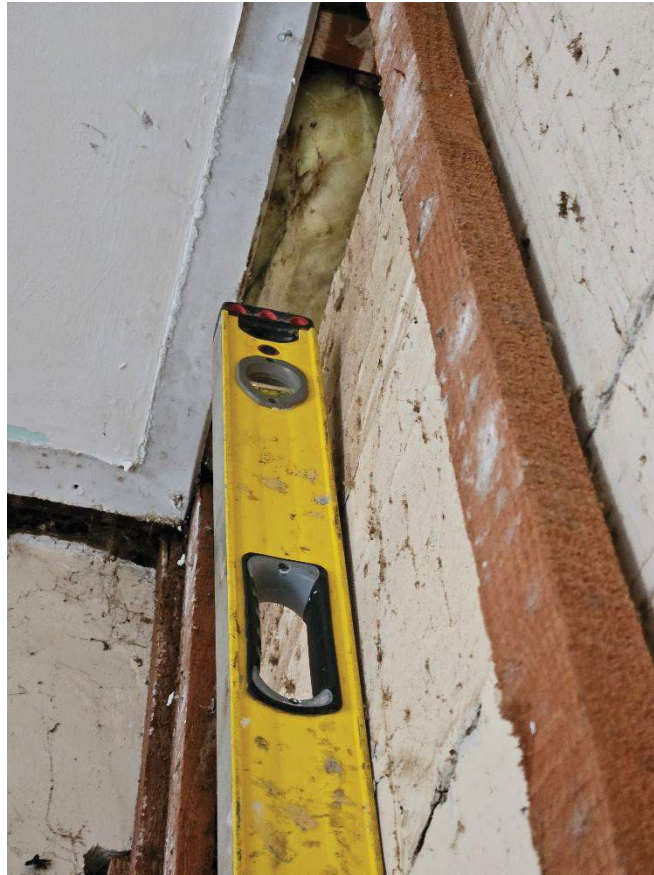
Photo 17 – Close up of top of straight edge shown in Photo 16

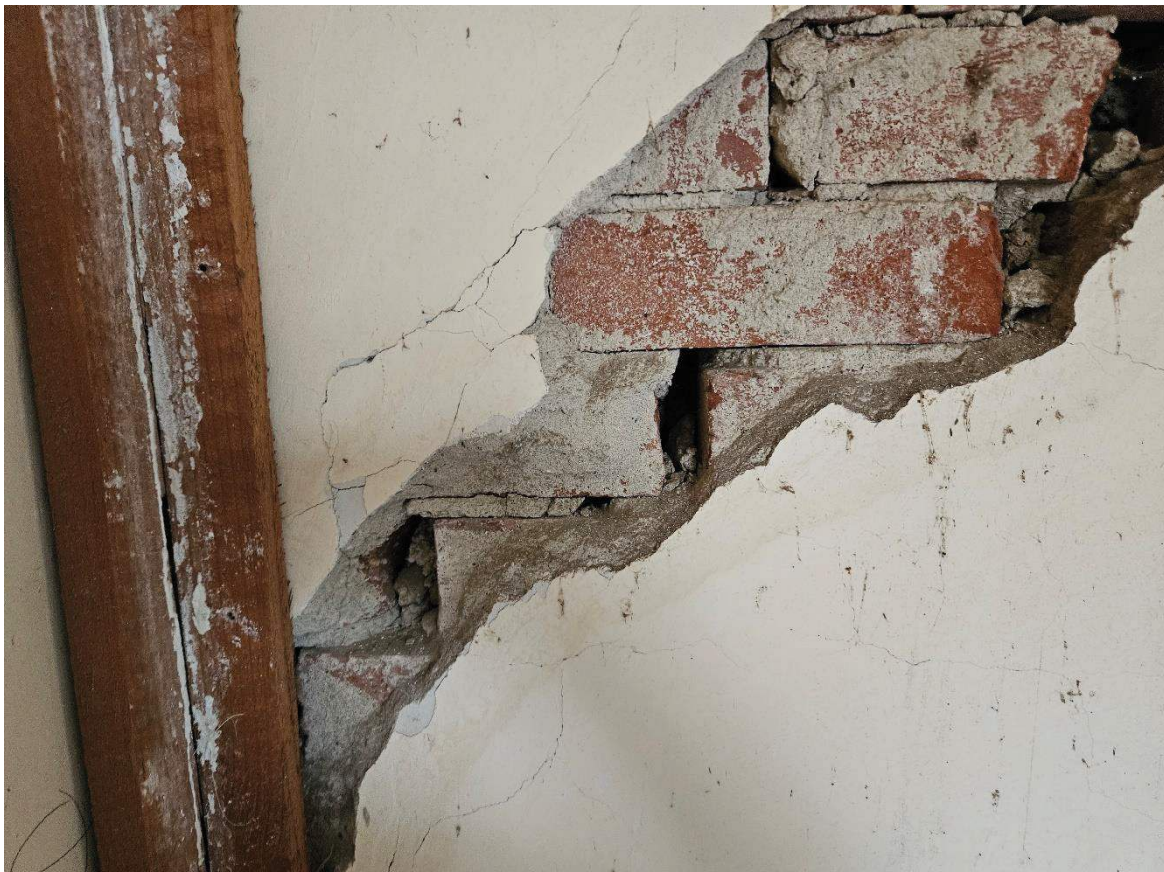
Photo 18 – Cracking to Living room's northern wall

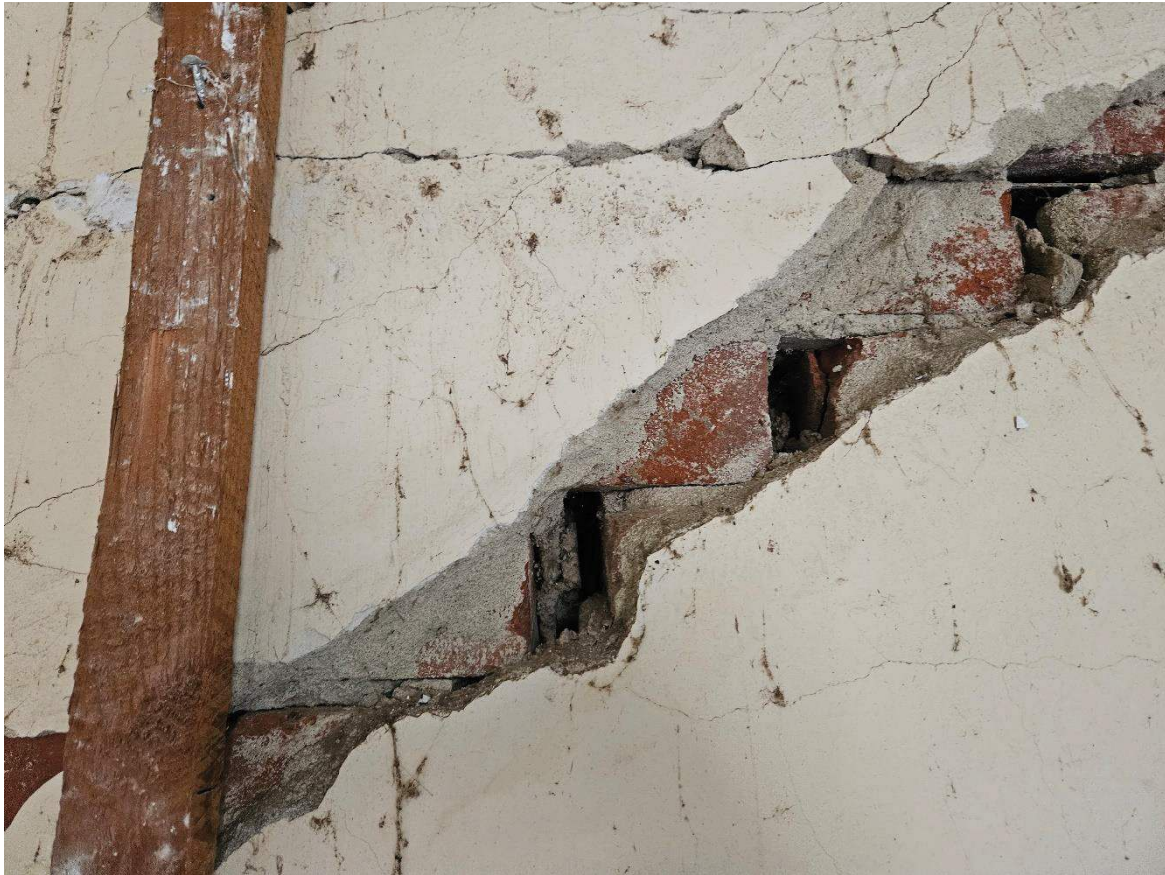
Photo 19 – Cracking to Living room's northern wall

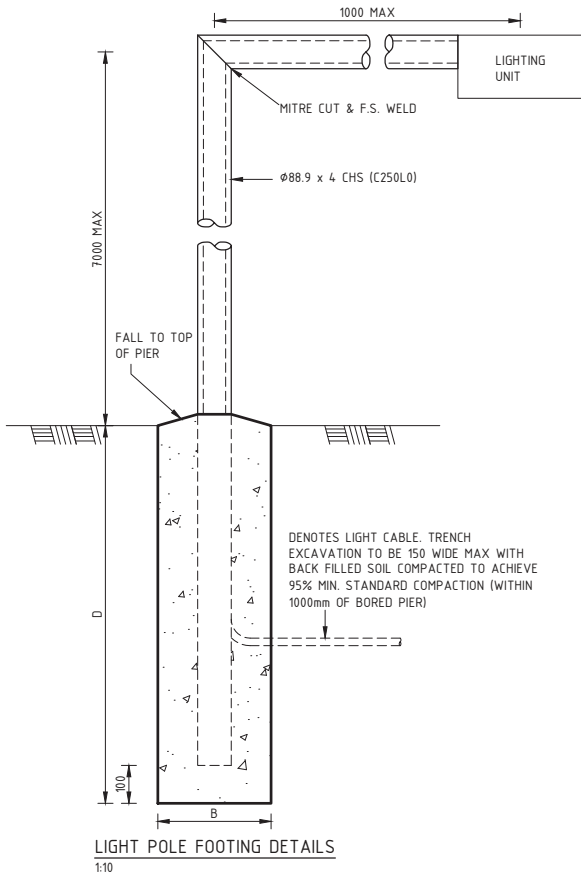
SOIL TYPE	PIER Ø DIAMETER (B)	PIER DEPTH (D)
'POOR'	300 mm	1450 mm
'GOOD'	300 mm	1000 mm

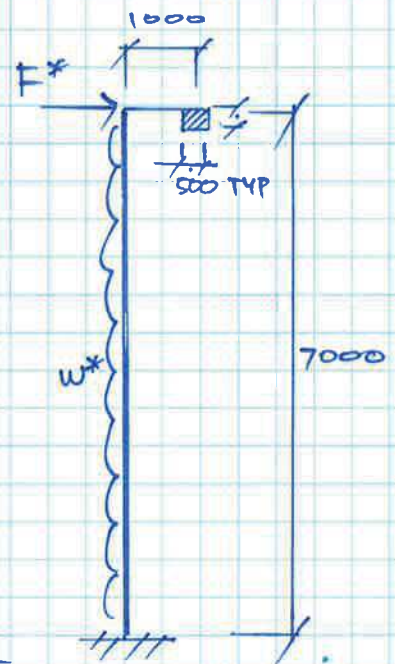
PAD & PIER FOOTING DESIGN FOR NON-BUILDING STRUCTURES

$$\text{combined: } \frac{4.6 \text{ kNm}}{6.49 \text{ kNm}} + \frac{0.3 \text{ kNm}}{5.85 \text{ kNm}} = 0.76 \leq 1.0 \therefore \text{OK}$$

\therefore Adopt 88.9 x 40 CHS (250 L0, embedded 100 mm from the base of the bored pier

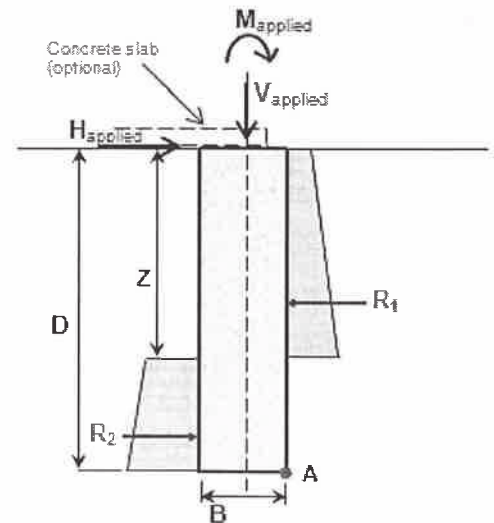
Forces Acting on Footing

RESISTANCE TO OVERTURNING

Disturbing Moment at point 'A' on base =	5.60 kNm
Passive pressure strength at surface =	14.52 kPa
Passive pressure strength at base =	62.46 kPa
Depth, Z, to passive pressure switch =	678 mm
Passive pressure strength at depth Z =	47.02 kPa
Total passive soil force (Upper zone, R_1) =	19.27 kN
Total passive soil force (Lower zone, R_2) =	4.58 kN
M.R. due to passive soil forces R_1 & R_2 =	6.20 kNm
M.R. due to cohesion on vertical faces =	0.31 kNm
M.R. due to friction on vertical faces =	0.16 kNm
M.R. due to gravity & applied vert. loads =	0.34 kNm
0.8* Σ M.R. (Due to all effects) =	5.61 kNm
Ratio (0.8* Σ M.R. : O.T. about point 'A') =	1.002 >1.00 :.OK

Showing Soil Passive Pressure Distribution

For design, M^* =	4.60 kNm
Section modulus =	0.003 m ³
Cracking moment =	4.27 kNm
Vertical reinforcement required =	60 mm ² central in footing

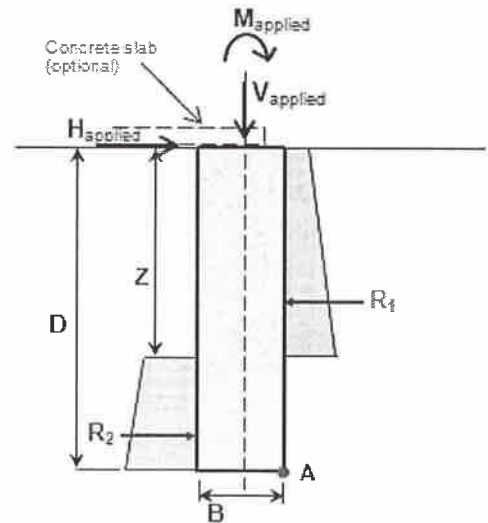
Forces Acting on Footing

RESISTANCE TO OVERTURNING

Disturbing Moment at point 'A' on base =	6.05 kNm
Passive pressure strength at surface =	3.26 kPa
Passive pressure strength at base =	72.77 kPa
Depth, Z, to passive pressure switch =	1037 mm
Passive pressure strength at depth Z =	52.97 kPa
Total passive soil force (Upper zone, R_1) =	26.97 kN
Total passive soil force (Lower zone, R_2) =	6.95 kN
M.R. due to passive soil forces R_1 & R_2 =	6.86 kNm
M.R. due to cohesion on vertical faces =	0.10 kNm
M.R. due to friction on vertical faces =	0.33 kNm
M.R. due to gravity & applied vert. loads =	0.46 kNm
0.8* Σ M.R. (Due to all effects) =	6.20 kNm
Ratio (0.8* Σ M.R. : O.T. about point 'A') =	1.025 > 1.00 :.OK

Showing Soil Passive Pressure Distribution

For design, M^* =	4.60 kNm
Section modulus =	0.003 m ³
Cracking moment =	4.27 kNm
Vertical reinforcement required =	60 mm ² central in footing

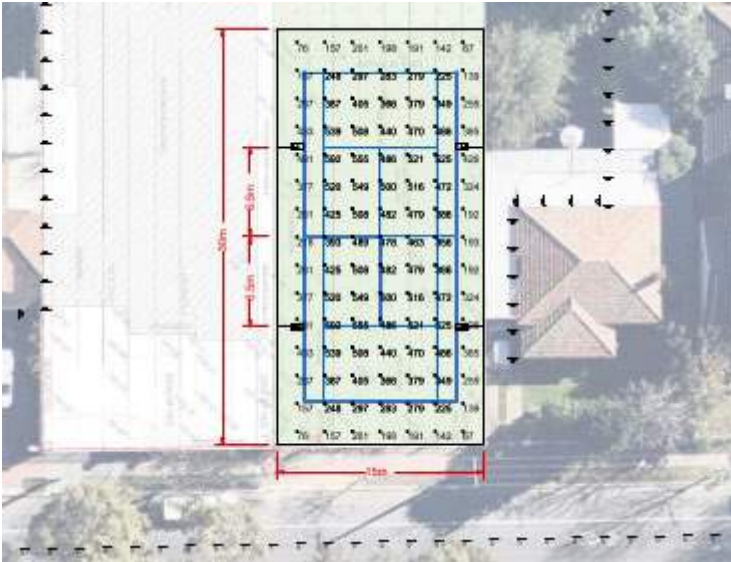
The structures are located within the site and behind the building line of the dwellings on the subject land and 68 Ninth Ave, this assists with mitigating visual impact (see figure 1).

Figure 1 - Proposed siting of the structures behind the building line of adjoining dwellings.

The proposed height of the structures for tennis court lighting is commonplace throughout the locality and wider City of Norwood Payneham St Peters Council Area.

They are slender in nature, and at a building height below Zone provisions.
