Special Council Assessment Panel Agenda & Reports

6 March 2024

Arboricultural Impact Assessment

Payneham Memorial Swimming Centre, 194 O.G. Road, Felixstow, SA 5070 Site Remediation Plan

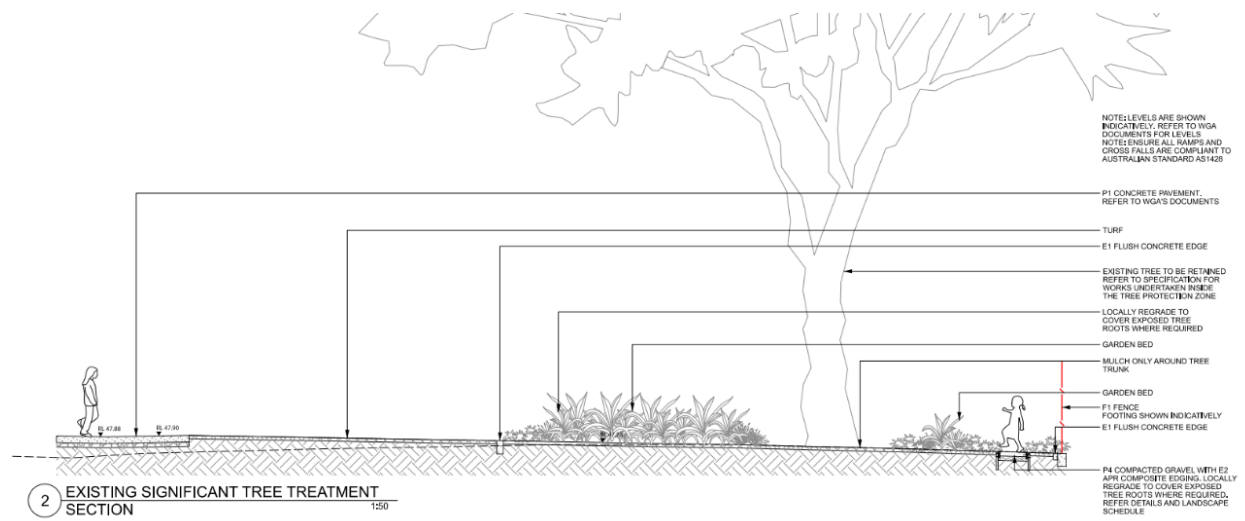
CROSS SECTION OF EASTERN SIDE OF POOL IF TREE 2 IS RETAINED – slope away from pool shown

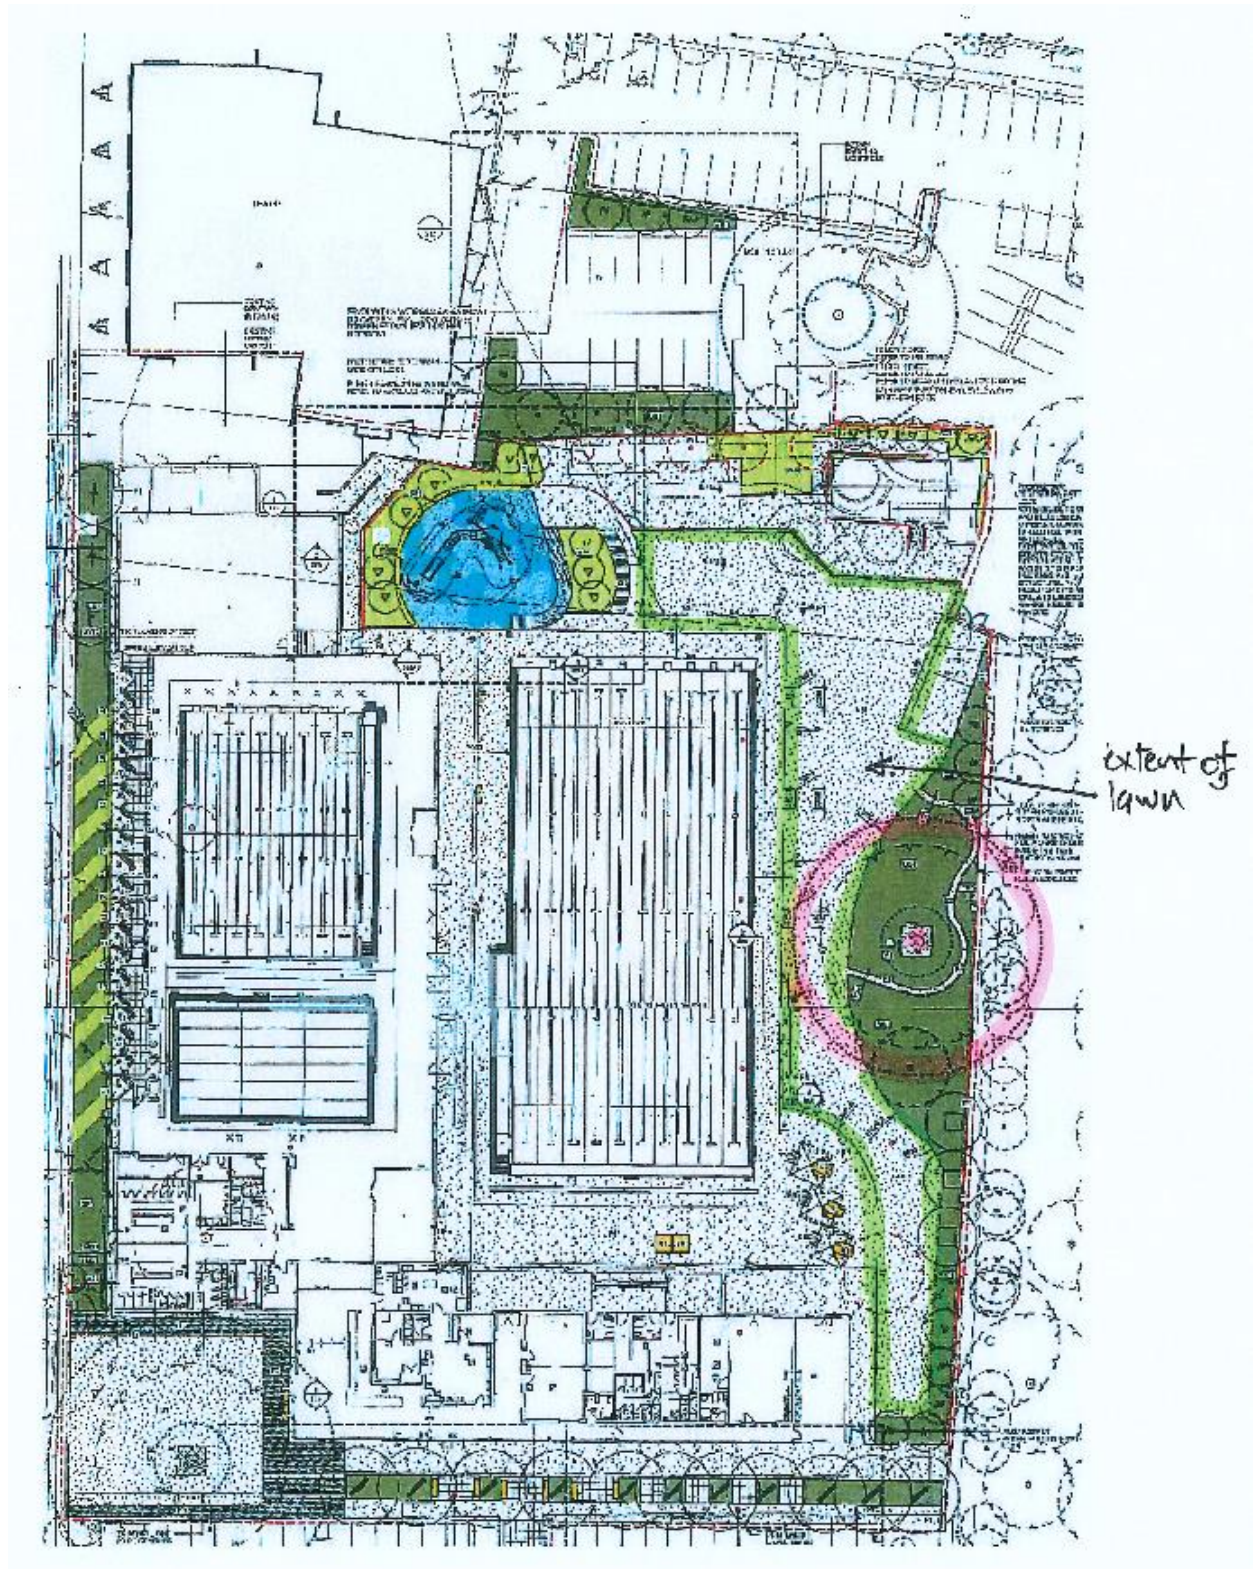
EXISTING LANDSCAPE PLAN OF THE EASTERN SIDE OF THE OUTDOOR POOL AREA

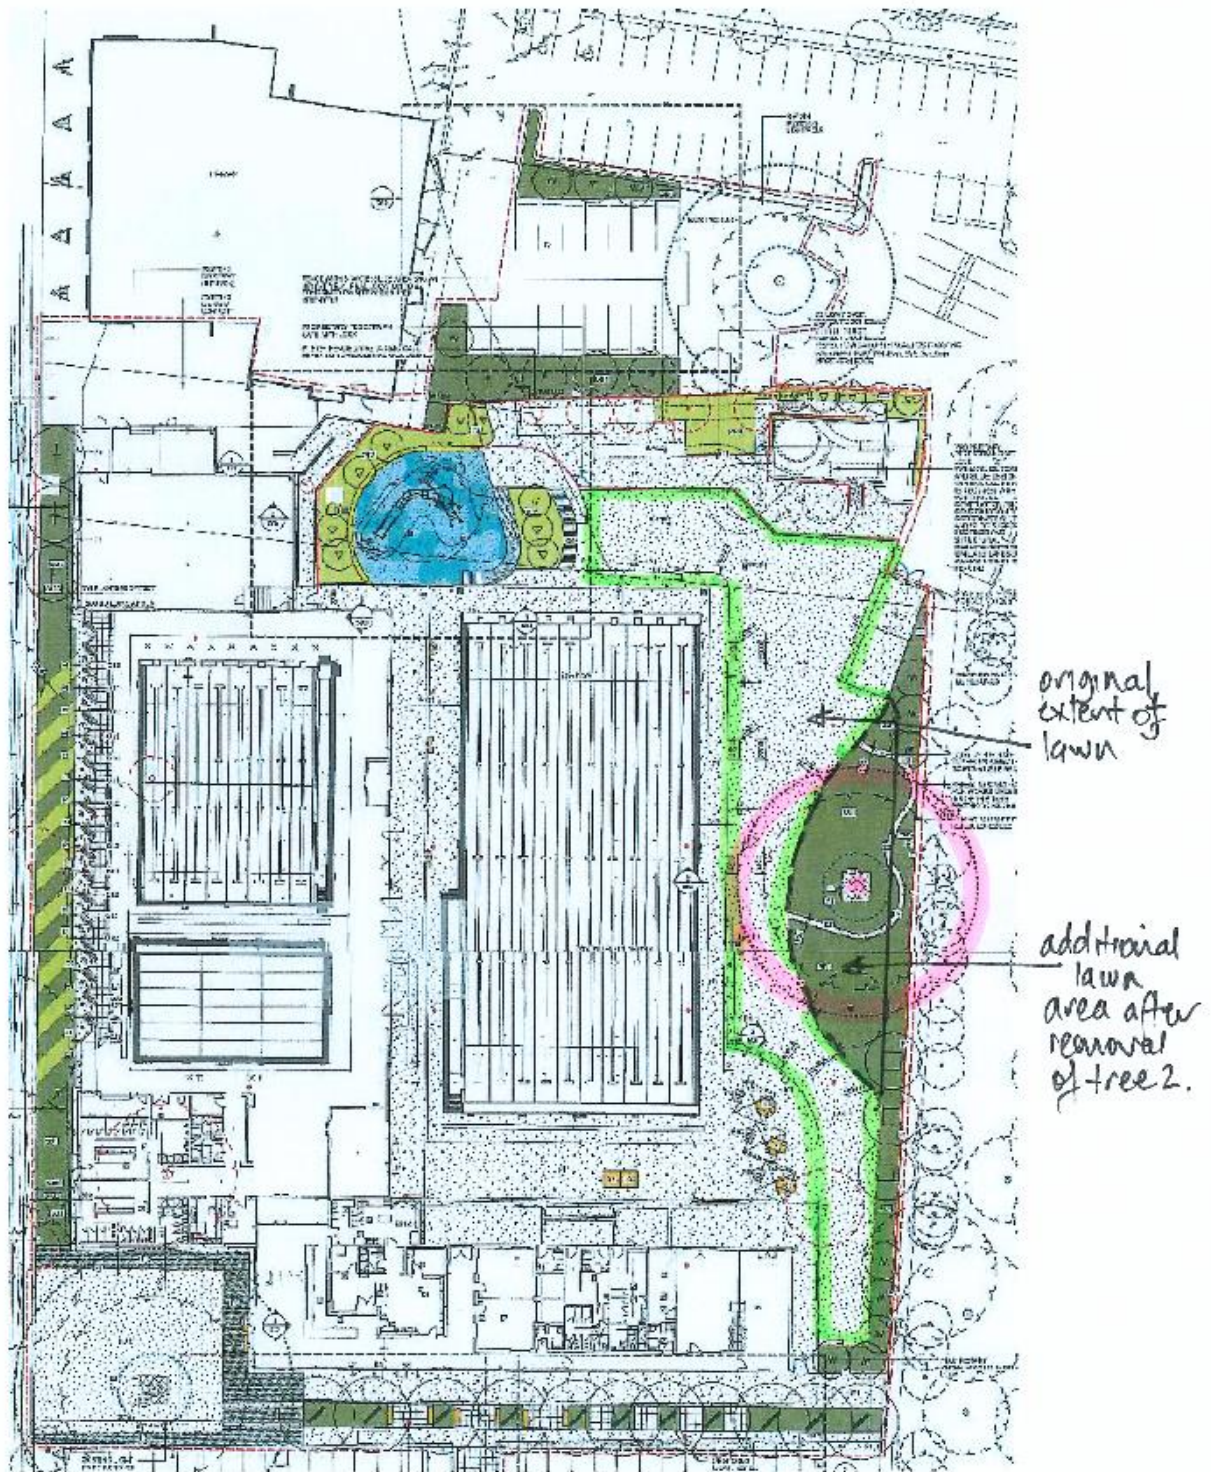
ADDITIONAL LAWN AREA SHOULD TREE 2 BE REMOVED

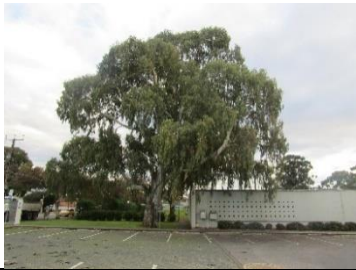
Tree 1

Species		<i>Eucalyptus camaldulensis</i>

Common name		River red gum	
Trunk circum. @ 1m		4.2m	
Legislated status		Significant	
Estimated size	Height	27m	
	Width	N/S 20m x E/W 19m	
Estimated age		60+ yrs	
Estimated useful life		20+ yrs	
Immediate Environment	Growing in a maintained lawn area 3.3m from the nearest site building. The area of crown overhanging the building has been managed with pruning but is still 8m+. The car park is 4.6m from the tree at its closest point. Overhang of car parking to the south is confined to 2-3 parks and has also been regularly reduced. The lawn is in good condition indicating a regular supply of water, and the tree presents as having grown with strong vigour as a result.		
Health	Good – presents as a healthy river red gum based on crown density, leaf condition and evidence of occlusive growth over wounds. It is likely able to experience some root disturbance and remain in good condition.

Structure	Fair – a large tree that shows indicators of fast growth. The white lower bark and crown density support this assertion. There is very little root flare at the trunk/ground interface. There could be various explanations but the trunk presents as well attached to the ground. The major branch attachments look sound. There is some horizontal branch orientation. Hollowing of trunk areas is obvious. Some branch failures have occurred, with at least two of significant size. The tree appears to be popular with parrots that have been tearing at bark and contributed to hollow formation. There is a good supply of pruning points to help manage the crown going forward.

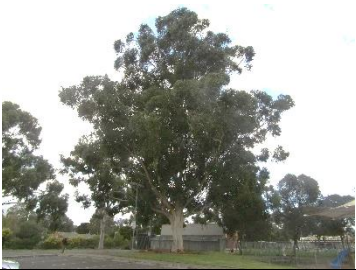
Tree 3

Species	<i>Eucalyptus grandis</i>

Common name	Flooded/rose gum		
Trunk circum. @ 1m	3.3m		
Legislated status	Significant		
Estimated size	Height	30m+	
	Width	N/S 20m x E/W 22m	
Estimated age	60+ yrs		
Estimated useful life	10+ yrs		
Immediate Environment	Growing in a maintained lawn area adjacent to car parking. The hard surfacing within the car park is permeable near to the tree. The local conditions would support the water requirement of this species. The only building in the vicinity is a plant room approx. 13m to the south, near the crown perimeter. A playground sits partially under the perimeter of the western crown.		
Health	Good – presents as a healthy flooded gum based on crown density, leaf condition and occlusive growth over wounds. Bark is in good condition throughout. The ground below the car park would be compacted to some degree but no major health impacts observed.		
Structure	Fair – typical of the species, a tall form but with multiple leading trunks that form between the 4 & 8m points. Branch attachments look well-formed. There is some branch orientation towards horizontal and few branches are starting to extend. Not hollowed or damaged by birds to the extent of Tree 2. Undulation of the permeable hard surfacing adjacent to the tree indicates the presence of large surface roots within the parking area.

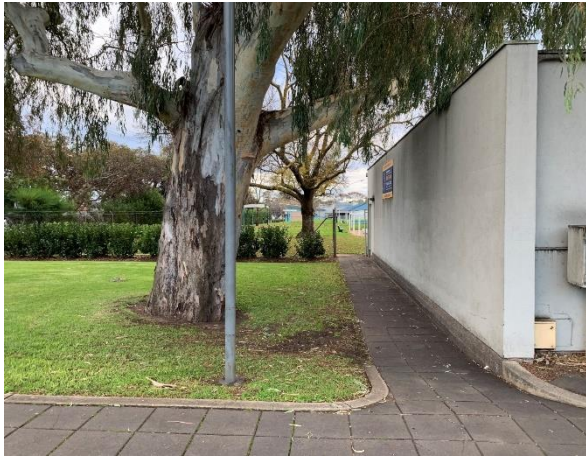
Tree 1. The new building is moving further from the tree. A small new encroachment to the north.

This is a mature tree showing good health and vigour. It presents as being able to cope with the degree of root disturbance likely to be caused by the development provided care is taken during the demolition.

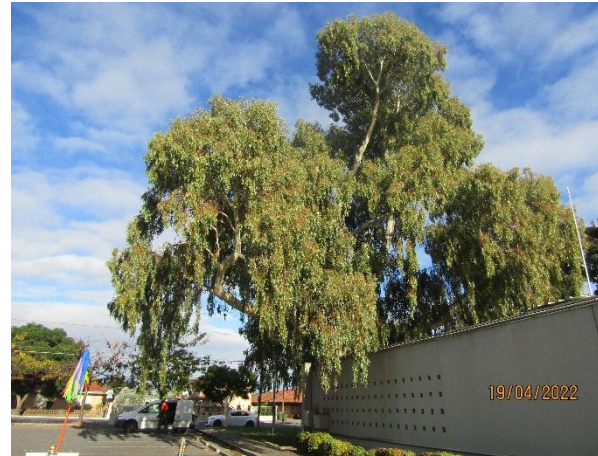
Tree 1. Some crown lifting may be required to complete the build but pruning points are available.

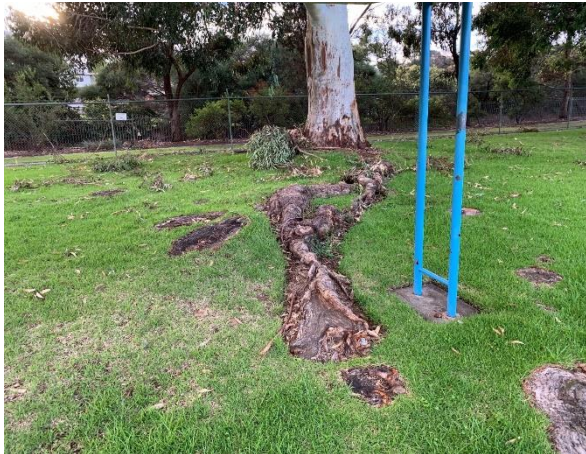
Tree 2. Large, exposed surface roots present as a trip hazard.

The main issue with use of the space appears to be the trip hazard of the large surface roots extending for 11m towards the main pool. A number of strategies could be considered in relation to management of the exposed roots. These include.

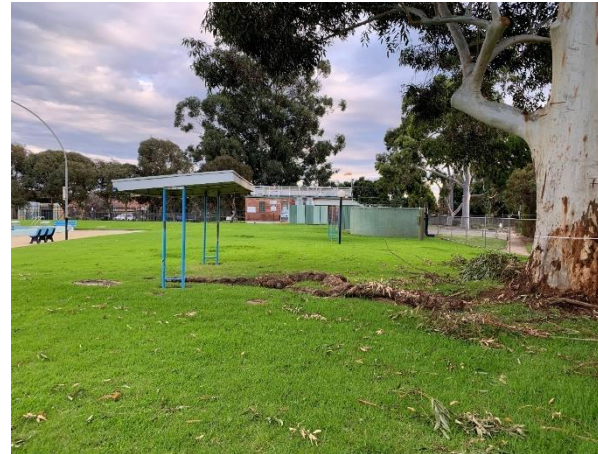
Tree 2. They extend up to 11m from the trunk. A low-rise lawned mound or decking present as options.

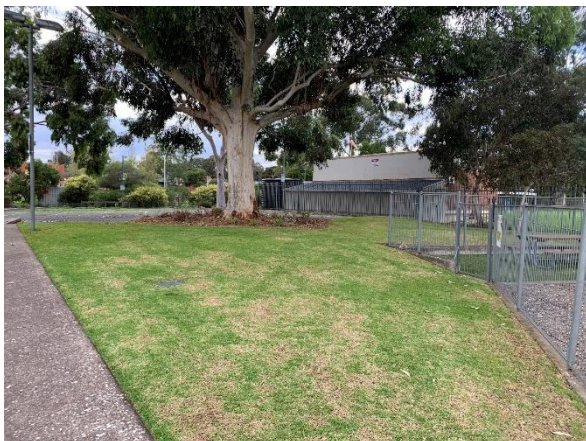
Tree 3. The lawn area is being reduced to be replaced with car parking. The loss of the only open ground within the TPZ may affect the tree.

Reducing the car park area would reduce the encroachment and would be a better outcome for the tree. Reducing by 2 spaces would reduce the encroachment by 12-13% with the residual encroachment approaching the 10% recommended as the maximum permissible within AS4970. Installing the car park without excavating would also likely reduce the impact. Site levels suggest this may be possible.

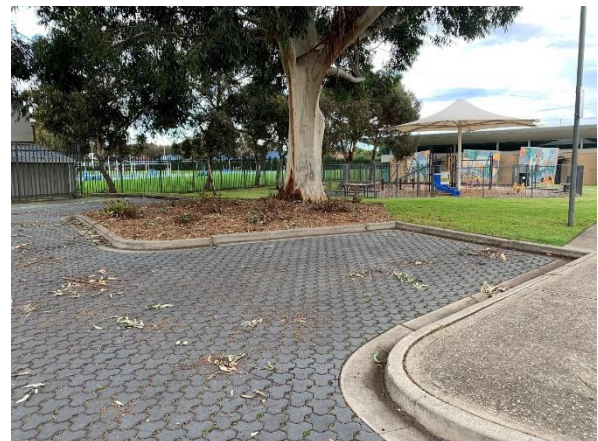
Tree 3. Permeable paving can minimise impacts.

Hard paving within a TPZ can impact on tree health by installing impervious surfaces, and by any required excavation works. Paving within the TPZ is recommended to comprise open jointed pavers or a permeable paving system to maintain water infiltration into the soil. If possible paving within the TPZ should be installed without lowering of grade to reduce the need for excavation.

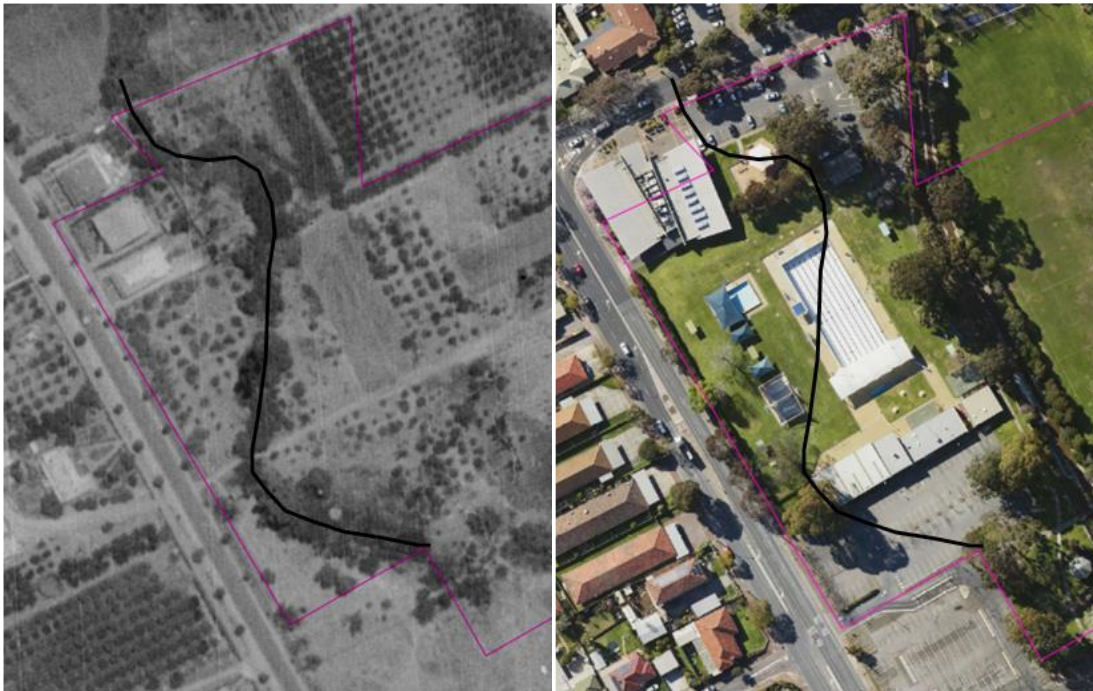
FIGURES 1 & 2: HISTORICAL AERIAL PHOTOS OF SITE

As further background, the Council engaged LBWco (environmental consultants) to undertake a Preliminary Site Investigation (PSI) of the Payneham Memorial Swimming Centre site. The PSI completed in March 2022, comprised a desktop site history investigation and limited intrusive soil investigation. The PSI desktop investigations found historical aerial photos which are contained in **Attachment 4**. As can be seen in **Figures 1 & 2** below, Third Creek originally ran through the site.

The creek was infilled and realigned along the eastern boundary to accommodate the development of the original swimming pool facility in the 1960s.

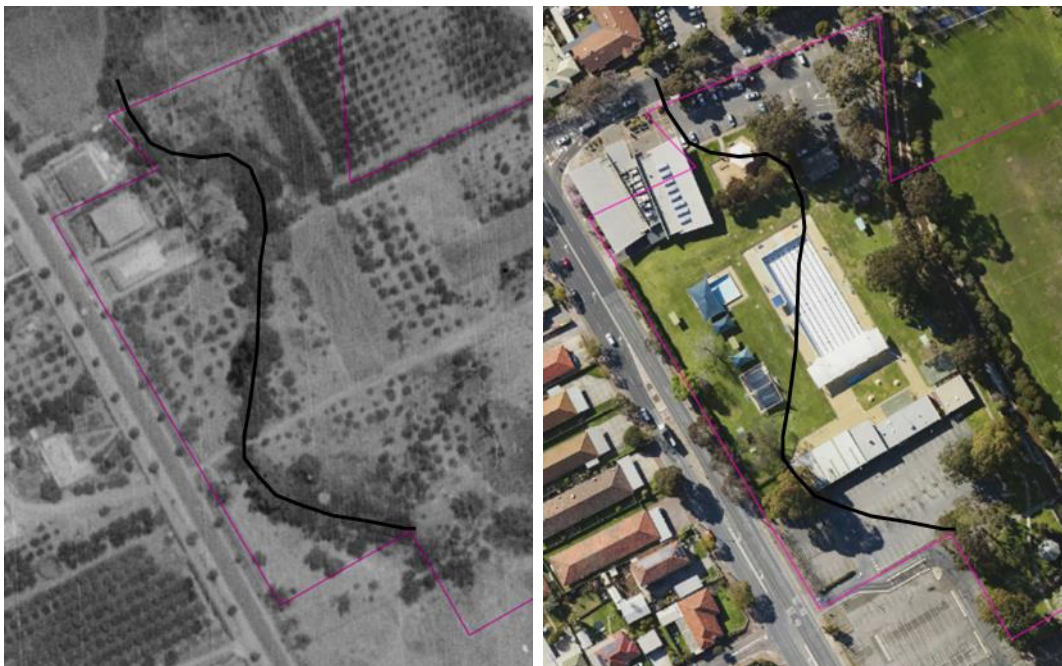
Figure 1 1949 and 2021 Aerial Photos Showing Inferred Creek Alignment

It is inferred that the creek entered at the south-western corner of the site, crossing the current 50 m pool location, and exited at the northern end of the site. The exact alignment of the original creek was not known but was inferred based on the centreline of trees crossing the site, as shown in the figure below.

Historical aerial photos indicated that Third Creek originally ran across the site prior to infilling and realignment along the eastern boundary of the site by 1968, ahead of development of the swimming centre. The source of the creek backfill material is not known and may contain construction and demolition waste, rubbish and/or contaminated fill.
